Professional Building Inspection Service
11757 W Ken Caryl Ave, F-219 - Littleton - CO - 80127
303-346-2250 - www.InspectProLLC.com

123 Main St, Any Where

Date Inspected:
December 44, 2099

Prepared for Our Client:
John and Jane Doe

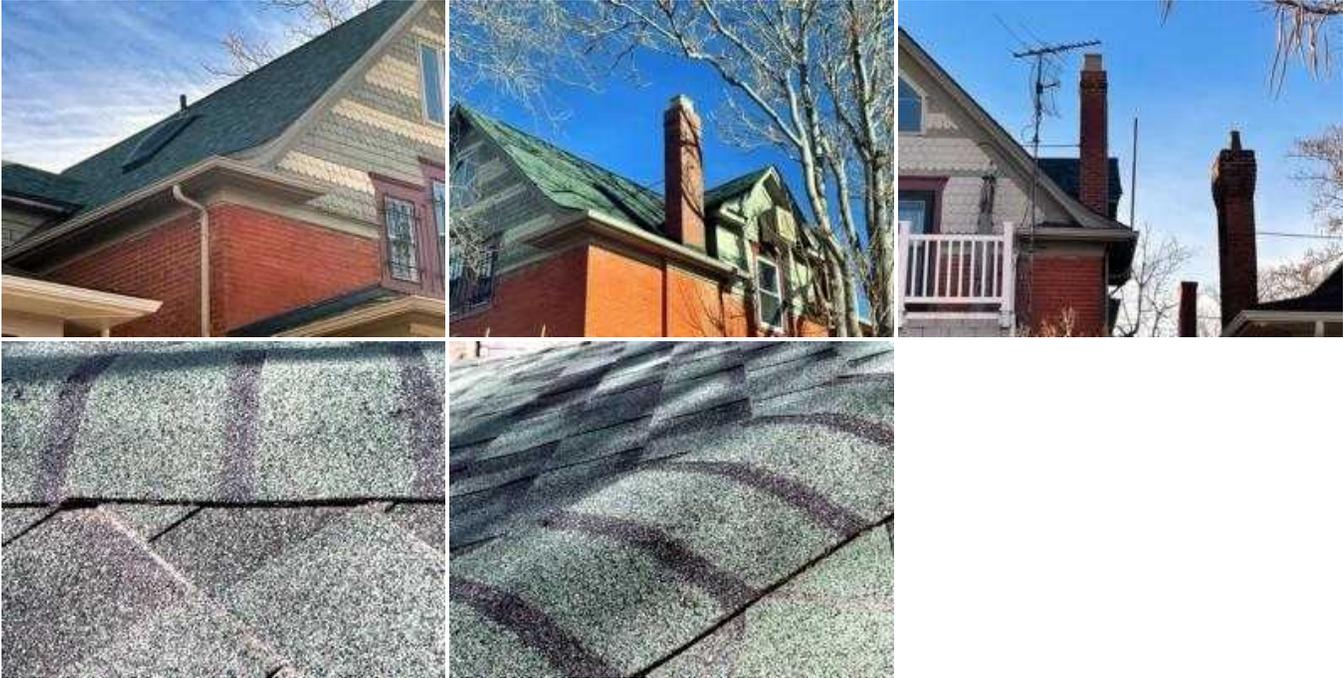
5. **Roof Surface Unable to Inspect:** *More than 75% VIEWED WITH LADDER - Portions of the roof were viewed from a ladder at the edge of the roof. Some sections of the roof were not in view., A qualified roofing contractor is recommended to further evaluate the entire roof, estimate repairs or replacement*

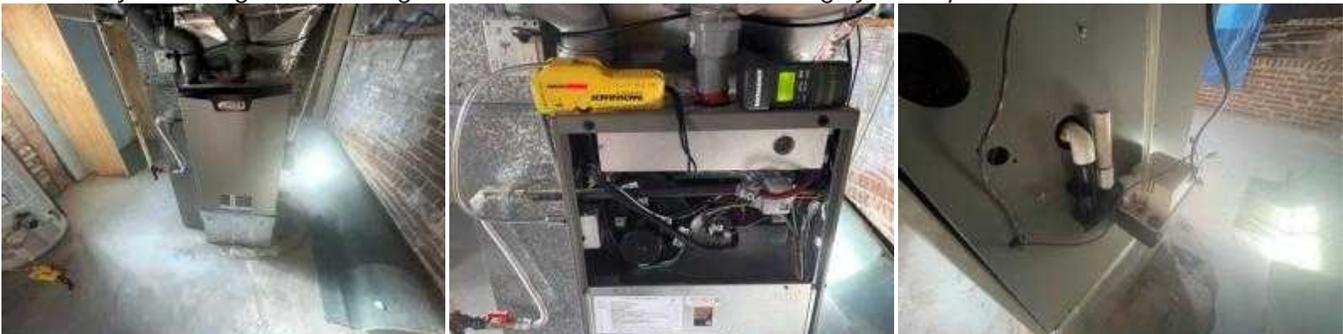
8. **Basement Heating System Operation:** *Operated at the inspection: Annual cleaning and servicing are needed for safe reliable heating system operation. THE HEATING SYSTEM SHOULD BE SERVICED FOR SAFETY AND FUNCTION - A qualified heating technician should clean and service the heating system and make necessary improvements for function and safety. Cleaning and servicing are needed for safe reliable heating system operation.*

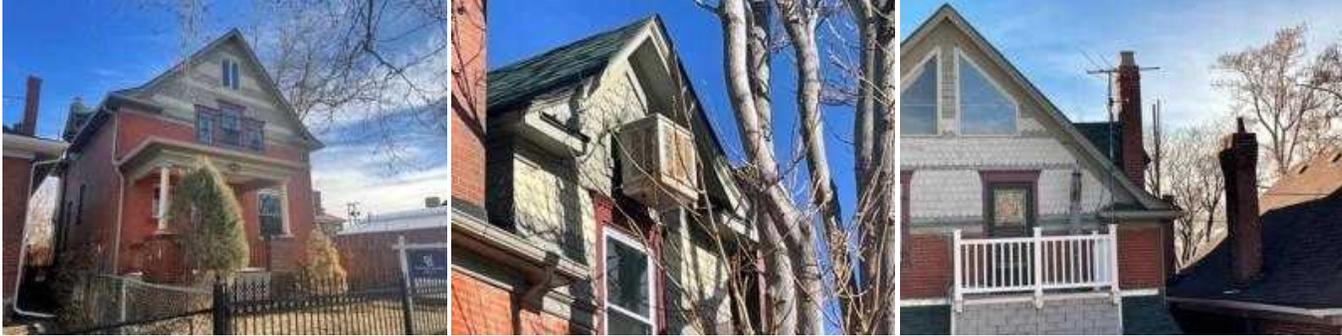
- 13. Exterior Surface General Comments About the Exterior:** **NORMAL WEAR AND TEAR FOR A HOME OF THIS AGE** The exterior of the home shows normal wear and tear for a home of this age., The exterior of the home has lacked some maintenance; repairs are needed.

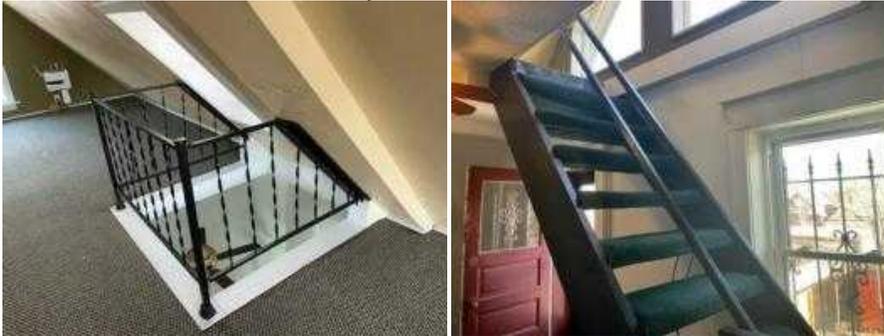
16. **Loft, Attic conversion Living Space HVAC Source:** *none visible No heat source*
17. **Loft, Attic conversion Living Space Stairs/Railings:** *Metal, Wood RAILING MISSING OR INCOMPLETE for improved safety, the guard railing should be installed, BALUSTER SPACING TOO WIDE - although this may have been allowed when this was installed, it has improper spacing by today's standards. Allow for improvements. The openings in the stairway railing are large enough to allow a child to fall through. It is recommended that this condition be altered for improved safety.*

RISE / RUN UNEVEN - are a trip hazard.

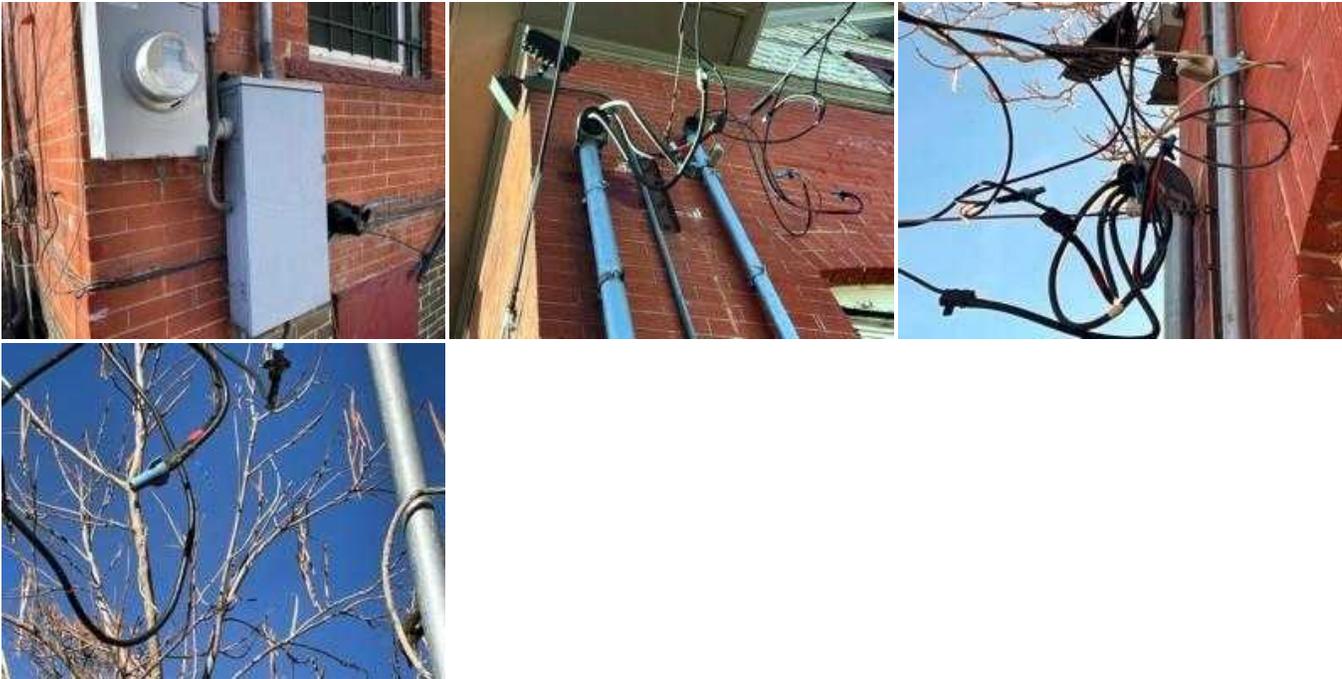
- 1. Electrical Recommendations:** *The electrical system has been modified. The owner should be consulted. Permits obtained and inspections performed by the local building official should be investigated., A qualified electrician should further evaluate the electrical wiring and make repairs as necessary.*
- 2. Electrical Mast:** *Overhead Improper wire connections of the garage service wires should be repaired or replaced as needed.*

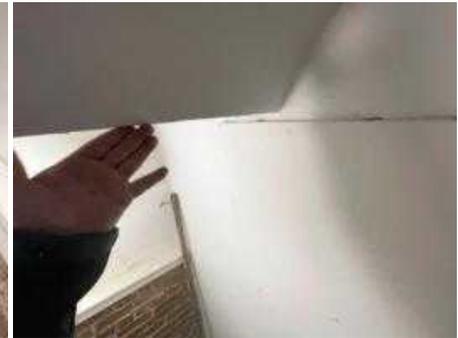
- 22. Basement Stairs/Railings:** *HANDRAIL MISSING OR INCOMPLETE - The handrail should be continuous for the full length of the flight of stairs., RAILING MISSING OR INCOMPLETE for improved safety, the guard railing should be installed, RISE / RUN UNEVEN - are a trip hazard., A qualified contractor is recommended to evaluate and estimate repairs., LOW HEAD HEIGHT - this is common for old homes.*

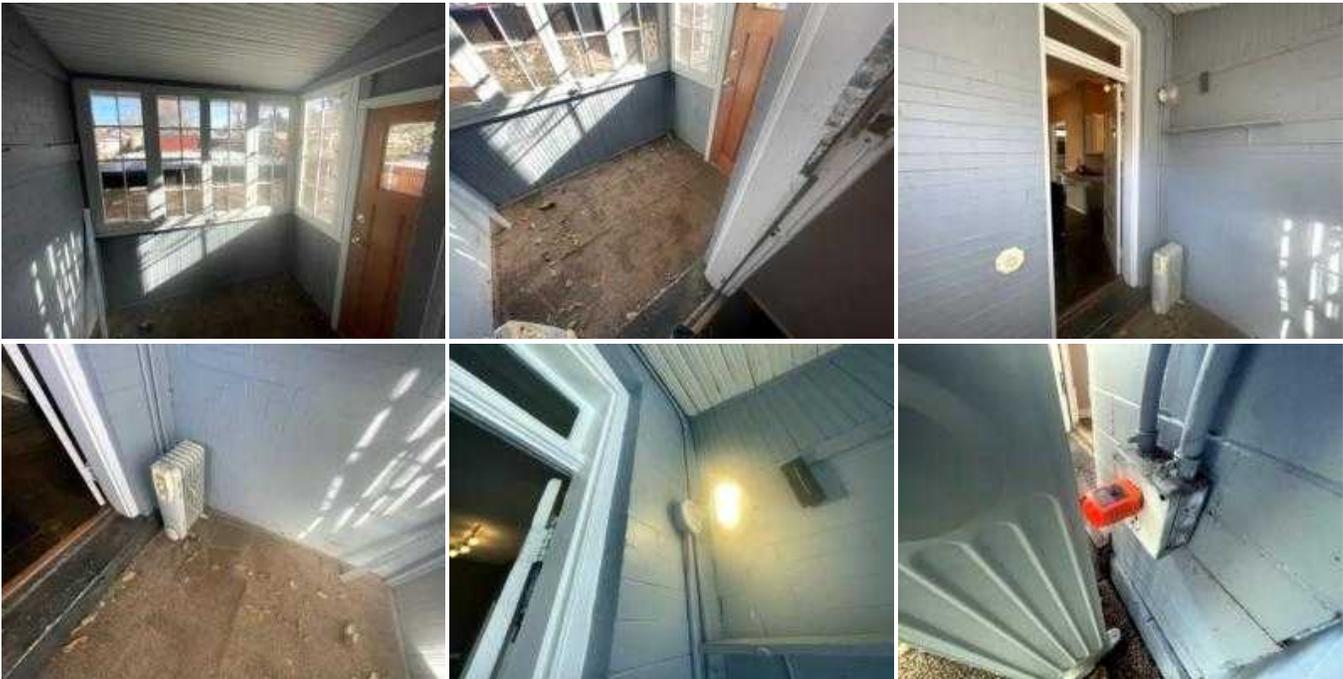
- 3. Altered Structure:** *Mud Room and Loft RENOVATIONS AND ALTERATION were visible at the time of the inspection. You should ask the seller for documentation showing that this work was done with the required permits and inspections. Allow for repairs not discovered during the inspection. Incomplete work and non-permitted installation are outside of our scope of service.*

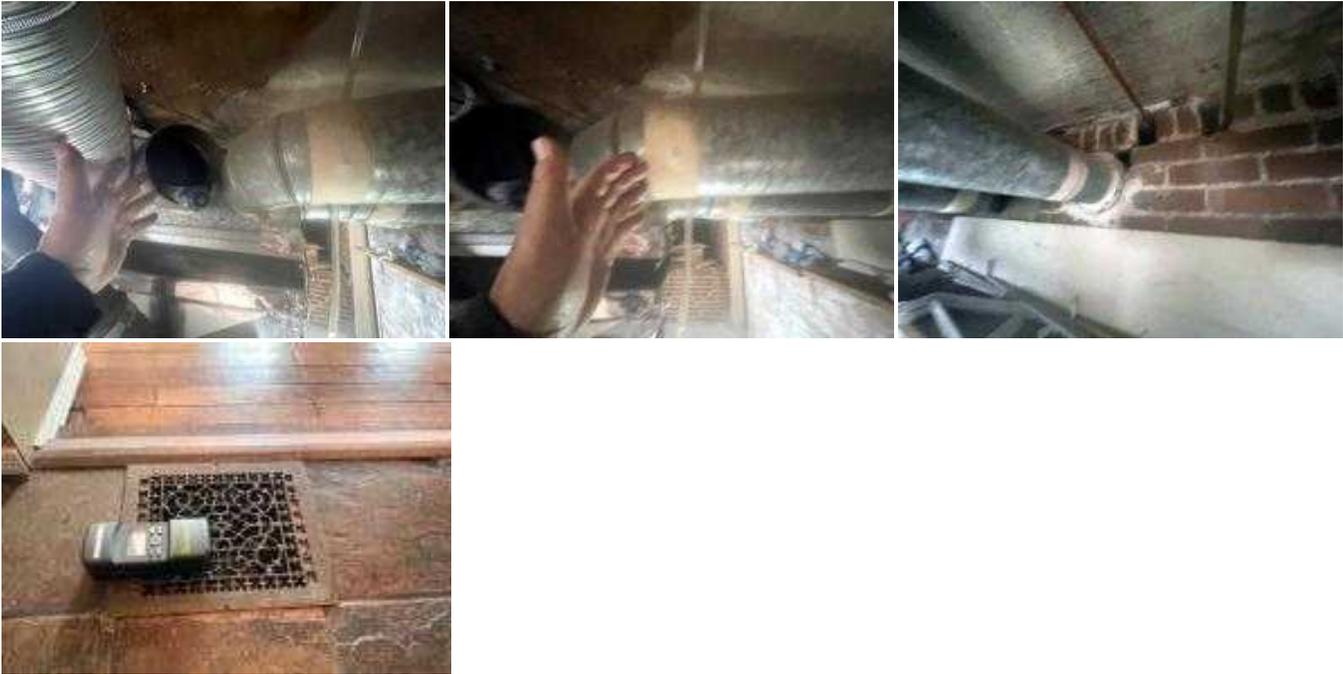
6. **Basement Heating System Heat Distribution Method:** *Ductwork Ductwork not ideally configured. This may inhibit heat distribution and may not be conducive to proper distribution of cool air, if air conditioning is employed. ACM - Possible asbestos containing materials (ACM) on ducts. This should be investigated and improvements made for safety and function.*

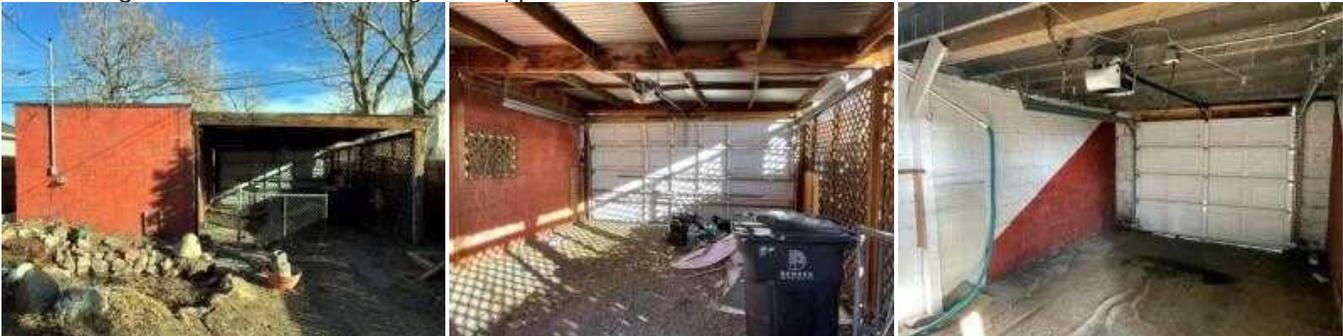
- 3. Back of Property Garage Type of Structure:** *Detached: LOW QUALITY. It may not be worth investing in repairs. Rebuilding would be the better long term approach.*

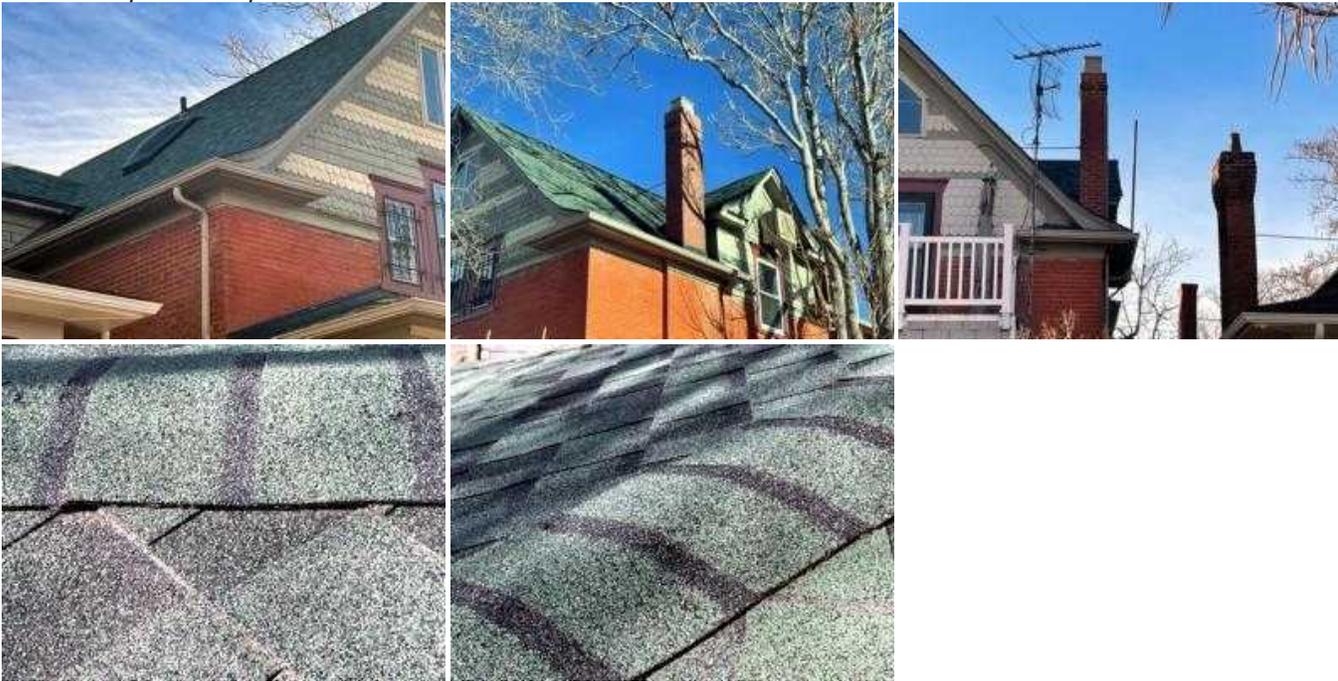
VIEWED WITH LADDER - Portions of the roof were viewed from a ladder at the edge of the roof. Some sections of the roof were not in view., A qualified roofing contractor is recommended to further evaluate the entire roof, estimate repairs or replacement

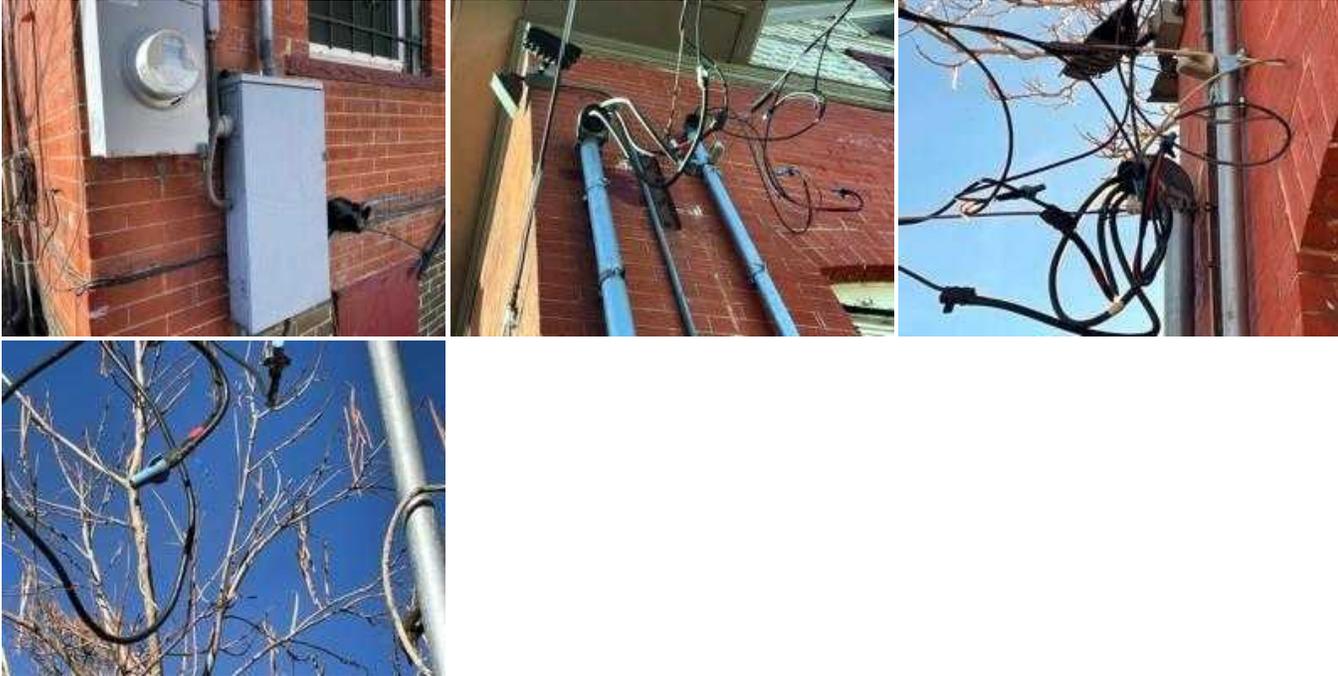
Improper wire connections of the garage service wires should be repaired or replaced as needed.

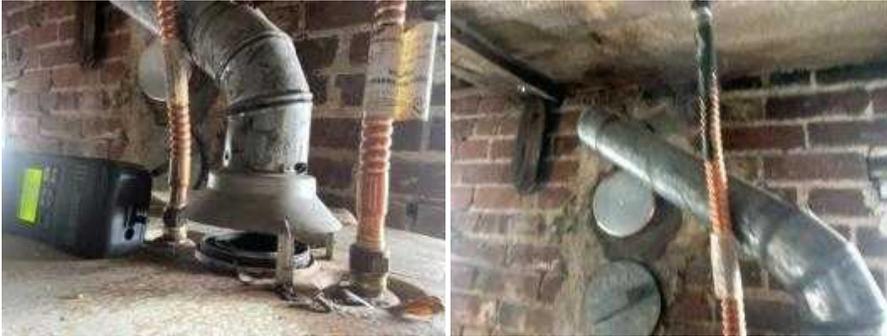
Inadequate Combustion Air- The supply of combustion air (and draft air) for the water heater may be insufficient. Inadequate combustion air risk improper system operation and can be a carbon monoxide risk. UNDERSIZED FLUE VENT - The size of the main flue vent should be investigated for proper sizing. Allow for repairs or replacement. Unit venting into unlined chimney this should be investigated.

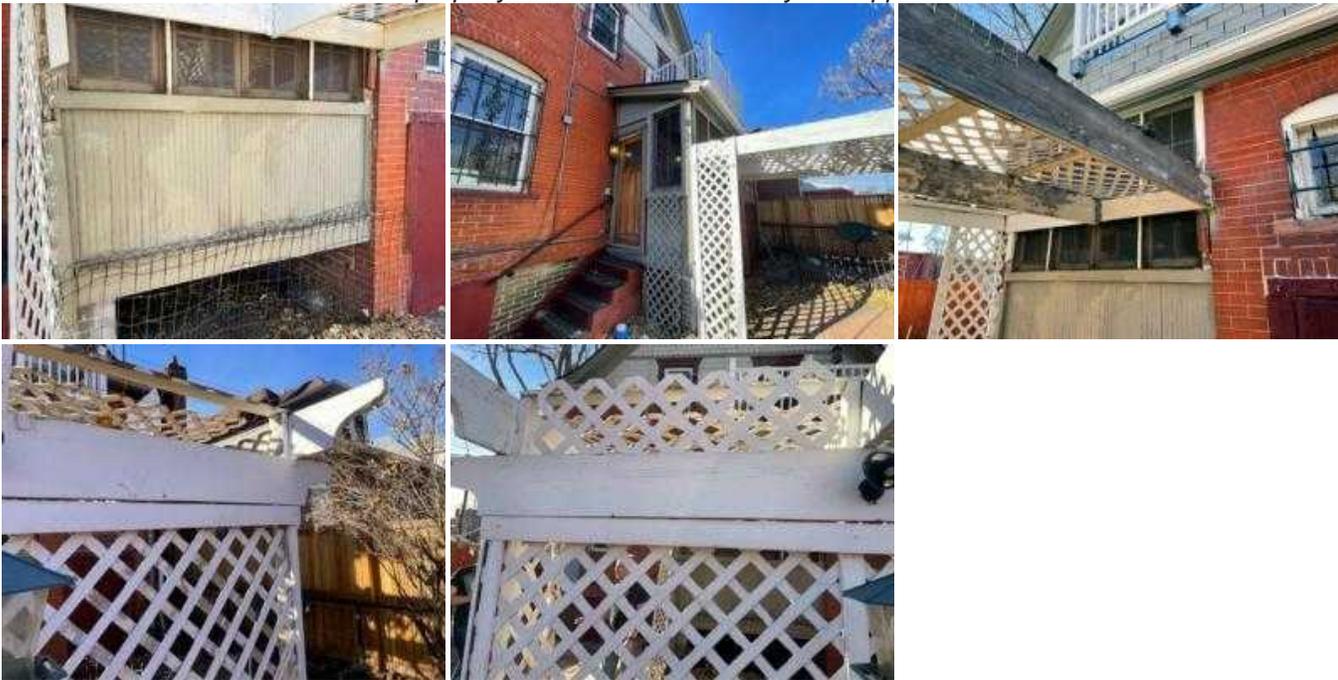
AGING STRUCTURE - The deck is noticeably aging and a deck tune-up is recommended. Allow for repairs or replacement. Typical flaws, weathering and rot were observed but do not appear to be impacting the integrity of the deck. The deck should be properly maintained for durability and appearance.

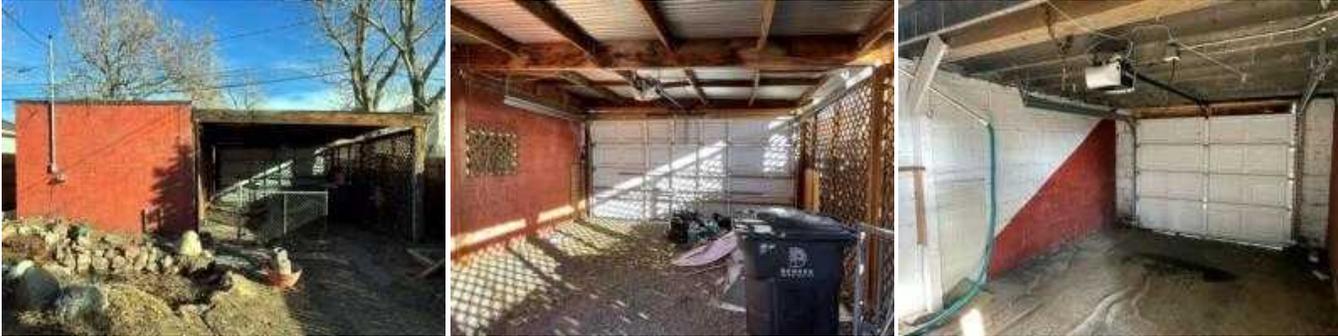
Type of Structure: *Detached: LOW QUALITY. It may not be worth investing in repairs. Rebuilding would be the better long term approach. DEFERRED COST:*

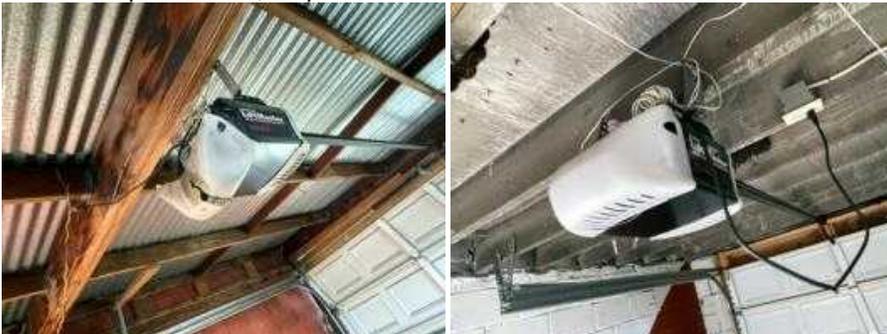
OPENER WOBBLER: Proper bracing for garage door opener is recommended., NOISY: The garage door opener is excessively noisy, this should be investigated., DAMAGED OR MISSING COMPONENTS: Allow for repairs or replacement., A qualified contractor is recommended to evaluate and estimate repairs

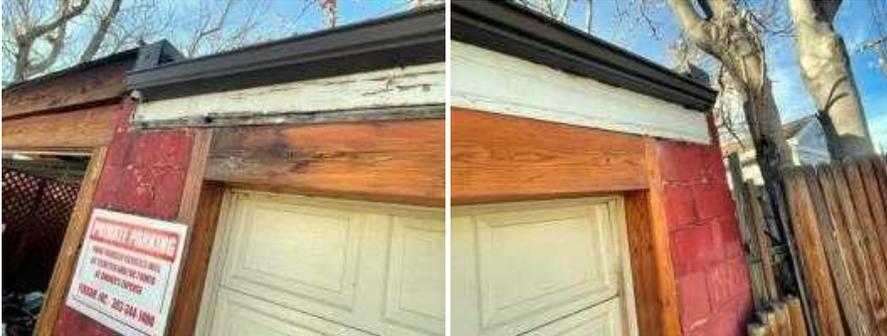
GAPS AT MATERIAL INTERFACES - Missing flashing and caulking at penetrations. Including but not limited to doors, windows and piping. This should be investigated for proper installation. Allow for repairs., DAMAGE - Damaged materials should be properly restored. Gaps, penetrations and material interfaces should be properly sealed. Missing or incomplete flashing should be installed. Soil or ground contact should be eliminated.

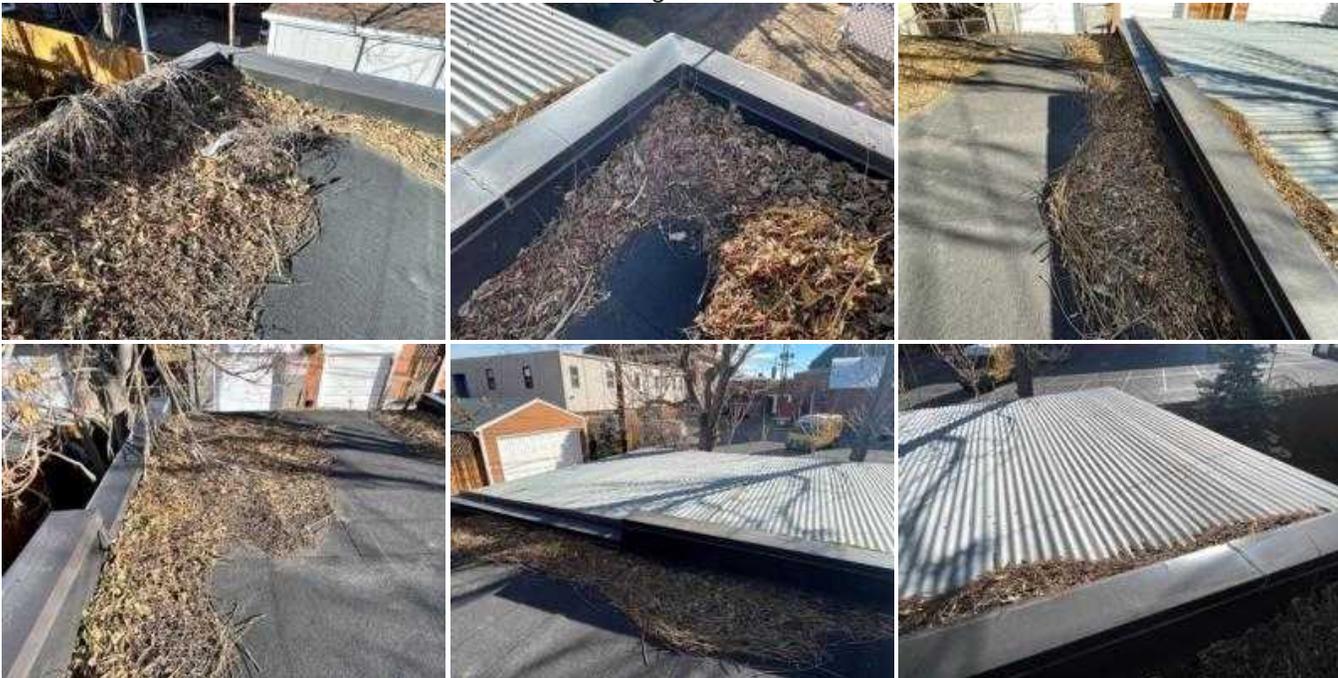
NORMAL WEAR AND TEAR - In all, the roof coverings show evidence of normal wear and tear for a roof of this age. Some typical indicators of aging (such as minor surface cracking and flaws) were visible. However, the wear is consistent over the entire surface and typical for a cover this age., DEBRIS - on the roof should be kept clear and the slope of the roof should be adjusted as necessary to avoid water ponding., FLAT OR LOW SLOPED ROOF - It should be noted that flat roofs are vulnerable for leakage.

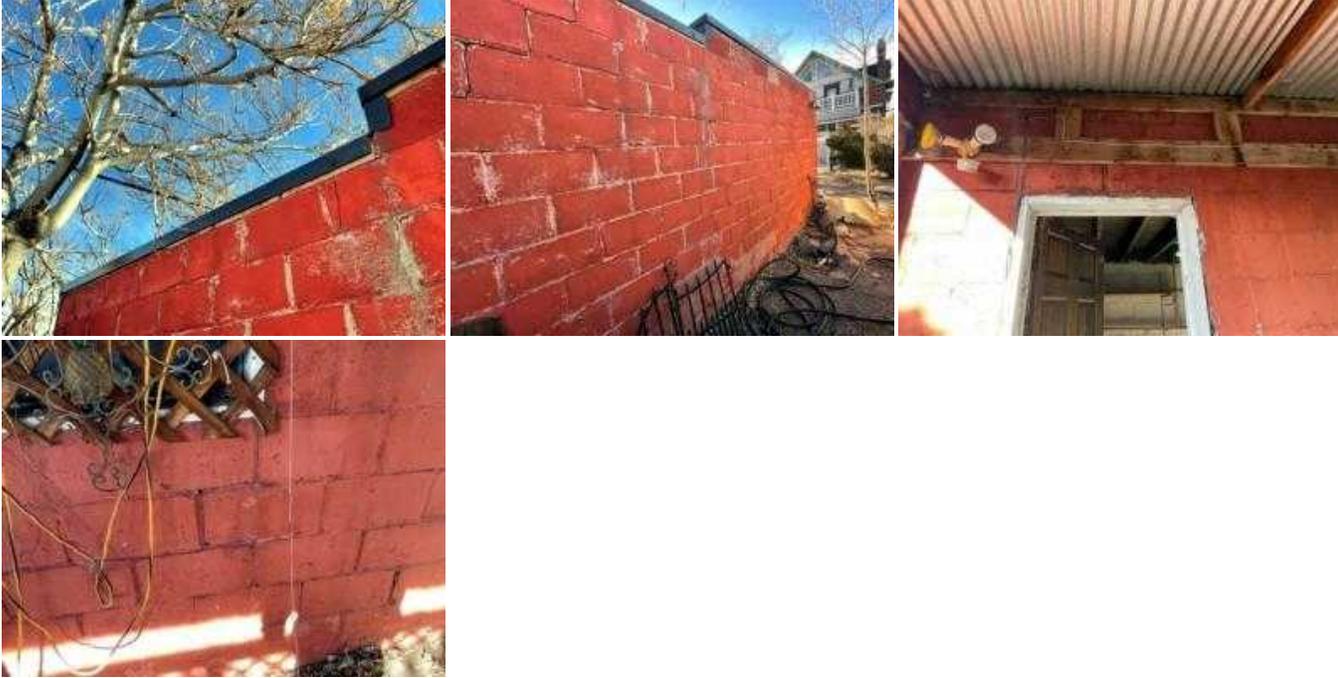
CRACKS was observed. In the absence of any additional movement only cosmetic repairs will be necessary. This should be investigated.

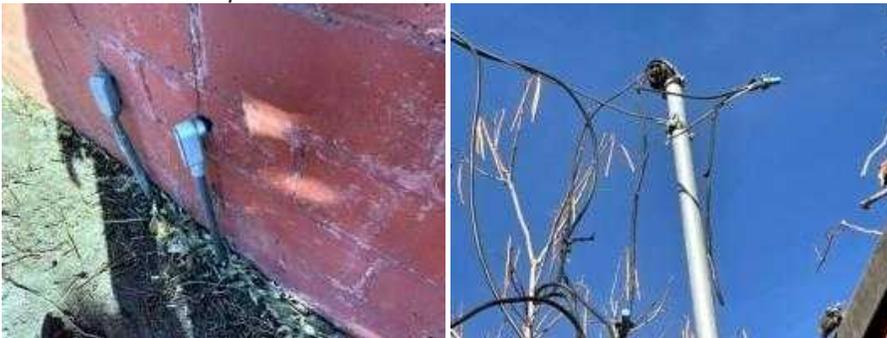
COVER PLATE MISSING, INSUFFICIENT NUMBER - of outlets for this space. Allow for improvements., *OPEN AIR SPLICES PRESENT* - connections should be made inside a proper box with a cover installed., *POOR WIRING* - Non standard wiring was observed, further evaluation and repairs is recommended, *EXPOSED OR SURFACE WIRE* - should be protected or relocated
