Professional Building Inspection Service
11757 W Ken Caryl Ave, F-219 - Littleton - CO - 80127
303-346-2250 - www.InspectProLLC.com

123 Main St, Any Where

Date Inspected:
December 44, 2099

Prepared for Our Client:
John and Jane Doe

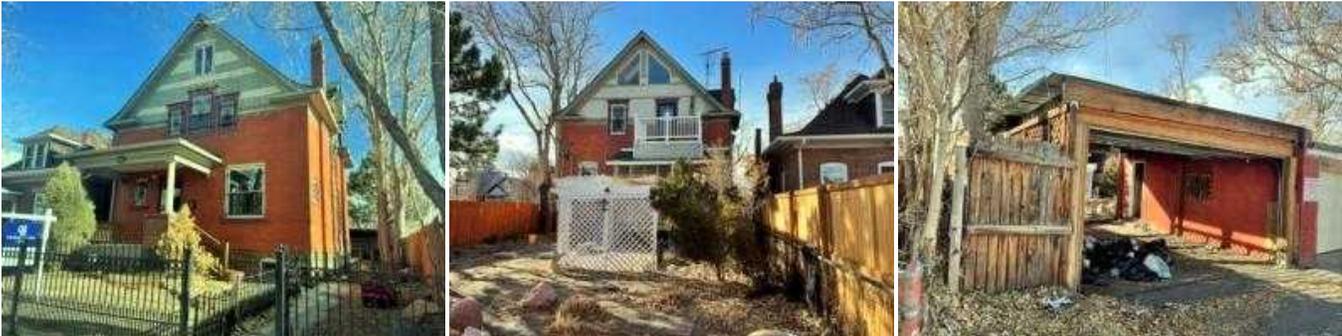
- 1. PROPERTY IN PERSPECTIVE: AVERAGE QUALITY - LACKING UPDATING AND MAINTENANCE** - *This appears to be an average quality 121-year old home that has been lacking maintenance and updating. Most of the systems of the home are aging and will require updating over time. This home is approximately 121-years old and the home inspector considers this while inspecting. It is common to have areas that no longer comply with current code. This is not a new home and this home cannot be expected to meet current code standards* **OLDER SYSTEMS:** *Most of the systems of the home are aging and will require updating over time. As with all homes, ongoing maintenance is also required. Despite the older systems, the improvements that are recommended in this report are not considered unusual for a home of this age and location.*

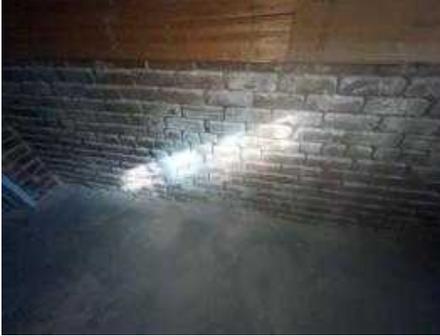
- 2. Foundation:** *Brick DAMAGED AND DETERIORATED* - *The brick foundations has mortar damage and deterioration. Allow for repair or replacement. This is a common maintenance task for masonry is repair of mortar joints. The longevity of mortar joints will vary with the exposure conditions and the mortar materials used, but a life-span of more than 25 years is typical. Re-pointing and parging deteriorated mortar joints is one of the most effective and permanent ways of decreasing water entry into brick. This is because the most common means of water entry into a brick wall is through de-bonded, cracked or deteriorated mortar joints.*

OLD FOUNDATION -*The foundation for this old home is typical for most of the structures in the area which have function satisfactorily for decades. Due to the configuration, the age of construction and the observed foundation, it is unlikely that the foundation could support the loading requirements found in today's codes. However, with repairs made to any damaged areas and modifications to the existing foundation, the system could still function in an acceptable manner.*

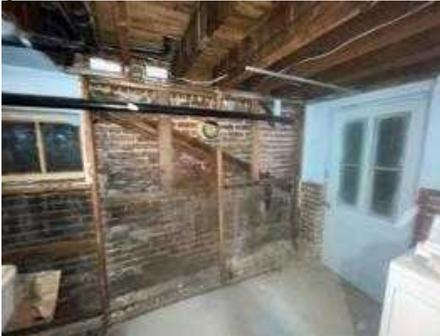
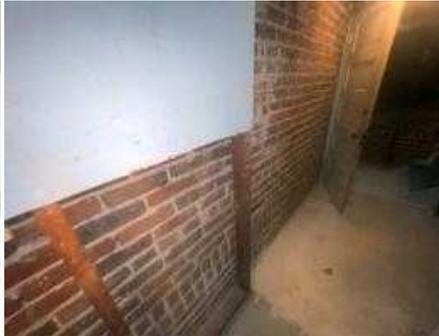
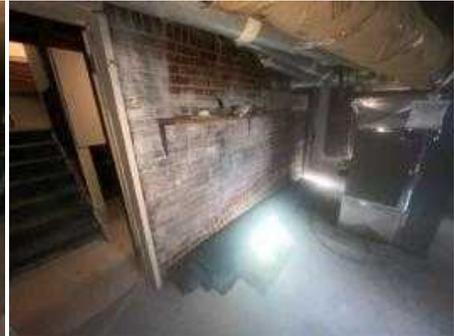
3. **Walls:** *Brick TUCK-POINTING IS RECOMMENDED - brick joints should be properly sealed.*

CRACKS TUCK-POINTED - in some areas, bricks were sealed by tuck-pointing. This is a common maintenance task for masonry is repair of mortar joints. The longevity of mortar joints will vary with the exposure conditions and the mortar materials used, but a life-span of more than 25 years is typical. The longevity of brick, however, may exceed 100 years. Consequently, occasional repair of the mortar joints is expected over the life of the material. It is our observation that the most common reason for re-pointing masonry is to improve water penetration resistance. Re-pointing and parging deteriorated mortar joints is one of the most effective and permanent ways of decreasing water entry into brick. This is because the most common means of water entry into a brick wall is through de-bonded, cracked or deteriorated mortar joints.

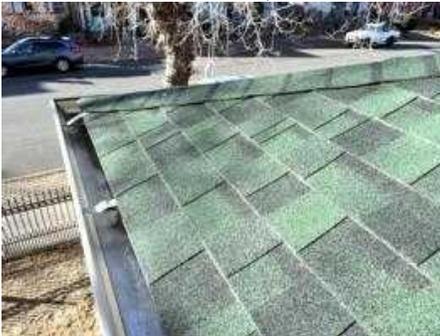
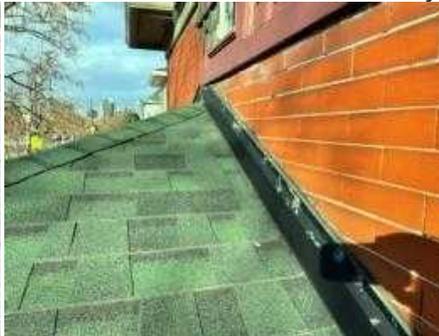
4. **Roof Surface Roofing Material:** *Asphalt shingle NORMAL WEAR AND TEAR - In all, the roof coverings show evidence of normal wear and tear for a roof of this age. Some typical indicators of aging (such as minor surface cracking and flaws) were visible. However, the wear is consistent over the entire surface and typical for a cover this age.*

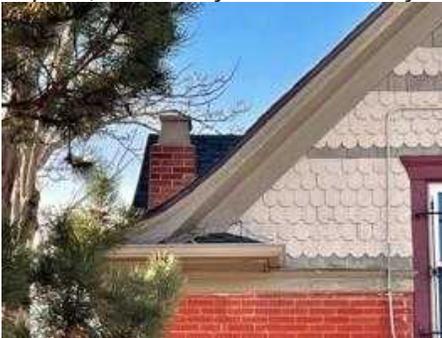
6. **Various Locations Chimney Chimney:** *Brick EVLAUATION - by a qualified contractor is recommended and estimate repairs, A chimney was not entirely visible during the inspection of the roofing system.*

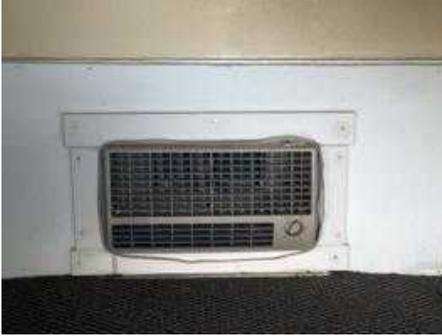
- 9. AC System Evaporative Cooler** Exterior side of home **SHUTOFF** - The system appears to be disconnected. A qualified technician should restore the unit to working condition and verify that the system is operating properly., **FURTHER EVALUATION** - A qualified technician should restore the unit to working condition and verify that the system is operating properly.

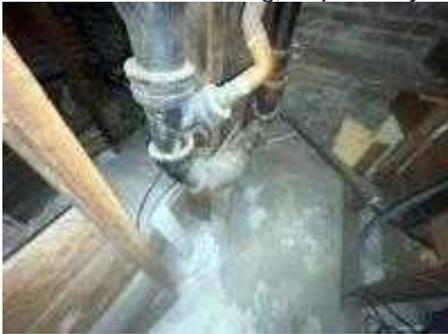
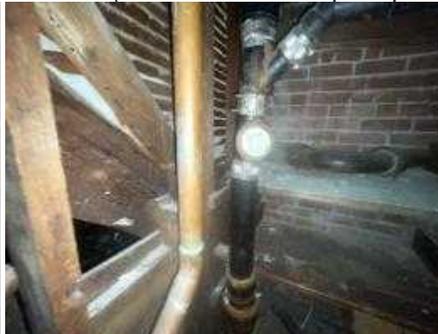
- 10. Drain Pipes:** Cast iron, Galvanized, Clay **CLEAN AND RE-SCOPE** - the waste line of the home should be further evaluated after cleaning, repair may be needed (see the sewer scope report for details).

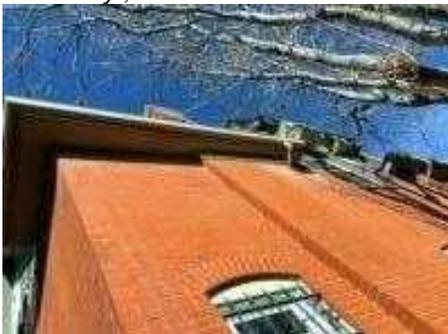
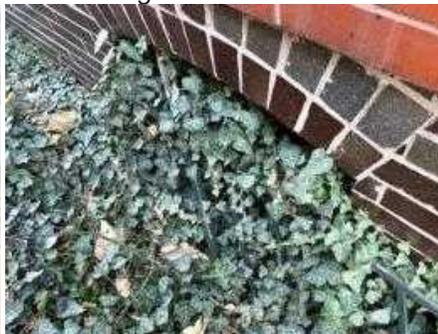
- 11. Vegetation:** **FURTHER EVALUATION** -by a qualified arborist is recommended, **TREES TOO CLOSE TO HOME** - may cause damage to the foundation or other components of the property. This should be investigated. Removing may become necessary., **PLANTS TOO CLOSE TO HOME** - Vegetation should be trimmed or removed.

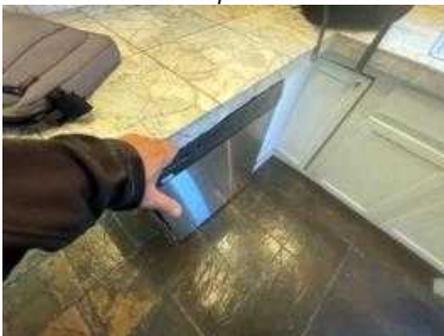
18. **Kitchen Dishwasher:** *Kenmore Inoperative, Dishwasher discharge line connects to disposal - although this was an accepted installation in the past it is recommended to have an air gap device installed to prevent dishwasher contamination in the event the disposal fills with water (ie - drain line plugs)*

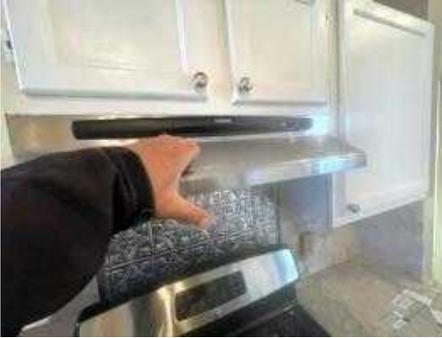
- 19. **Kitchen Disposal:** *Badger The disposal is jammed or seized, allow for repairs*
- 20. **Kitchen Ventilator:** *NuTone Inoperative, Does not vent to the exterior of the home.*

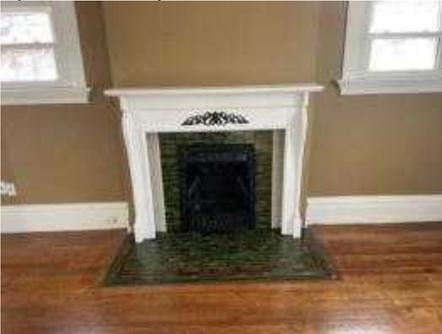
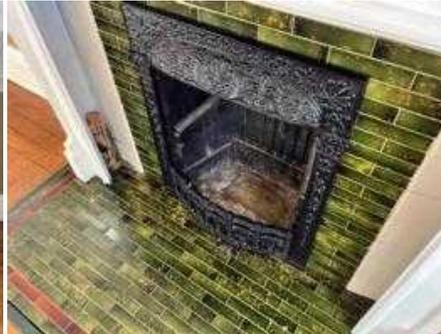
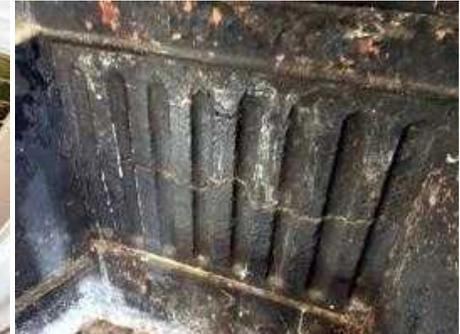
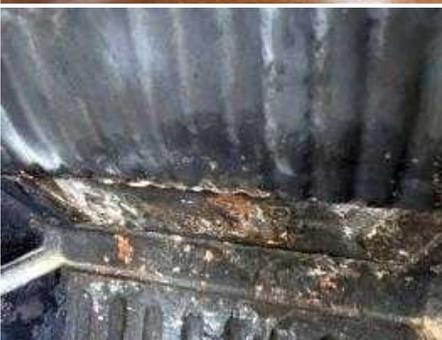
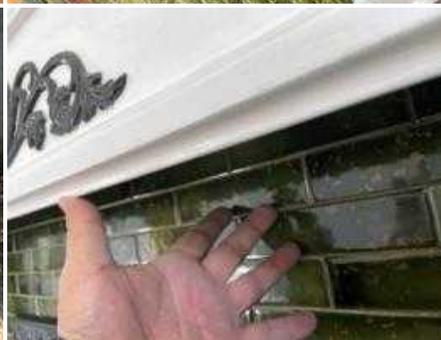
- 23. **Living Room Fireplace Fireplace Type:** *A qualified contractor is recommended to evaluate and estimate repairs to operate the fireplace safely. Damaged was observed. Improper clearance to combustibles. Damper inoperative. Allow for repairs and replacements.*

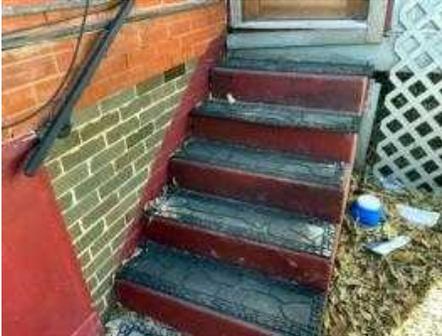
8. **Mud Room Enclosure Deck Stairs/Railings:** *Damaged The missing stair railing should be installed*

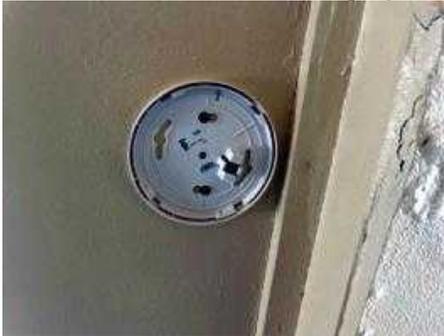
10. **Loft, Attic conversion Living Space Lights and Switches:** *None*
11. **Loft, Attic conversion Living Space Smoke Detector:** *MISSING detector should be replaced.*

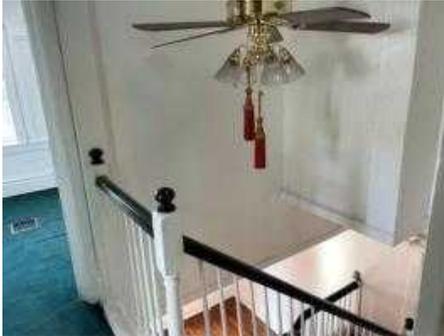
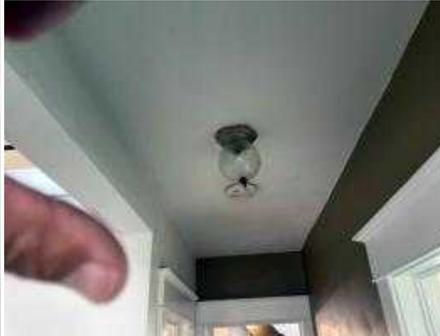
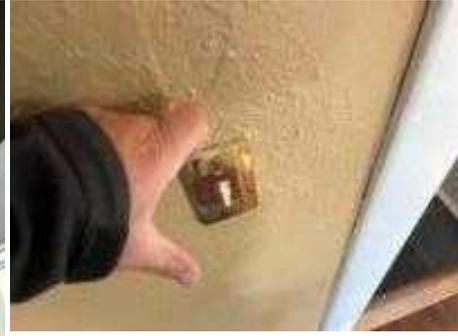
14. **2nd Floor Hall Living Space Lights and Switches:** *LIGHT INOPERATIVE - or that does not respond to controls are presumed to have burned out lamps. Dismantling fixtures to confirm the status of bulbs is not performed during our inspection., Ceiling fan low height*

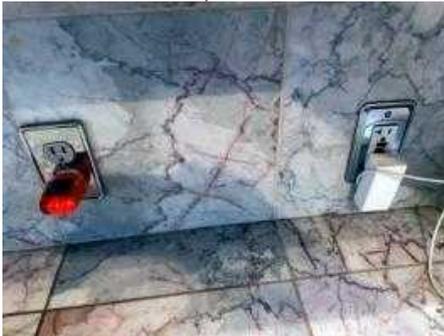
- 18. Kitchen GFCI Protection: *110 VAC GFCI TESTED PROPERLY - the GFCI circuit was tested and operated properly at the time of the inspection. NOT PROVIDED - at all proper locations. Allow for repairs per today's good building practices*

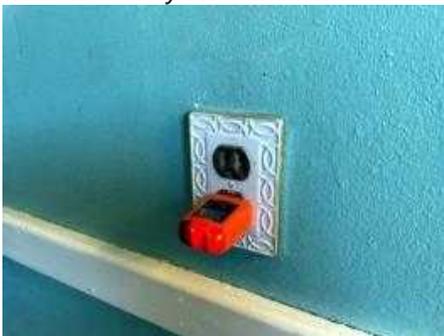
- 19. 2nd floor-Hall Bathroom GFCI Protection: *NOT PRESENT AS REQUIRED, this should be investigated and repairs made for safety and function.*

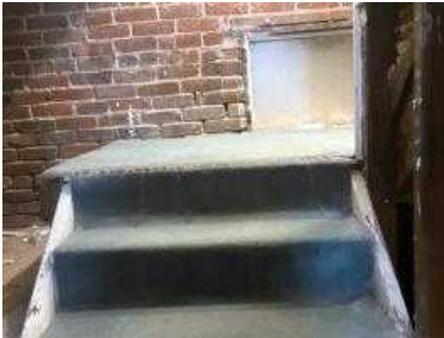
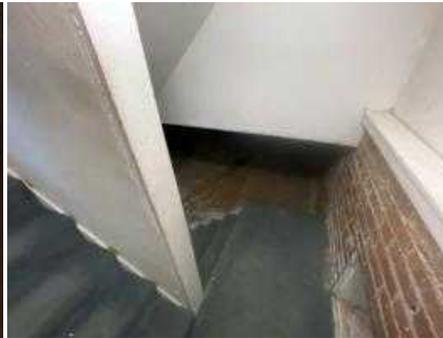
- 22. Basement Stairs/Railings:** *HANDRAIL MISSING OR INCOMPLETE - The handrail should be continuous for the full length of the flight of stairs., RAILING MISSING OR INCOMPLETE for improved safety, the guard railing should be installed, RISE / RUN UNEVEN - are a trip hazard., A qualified contractor is recommended to evaluate and estimate repairs., LOW HEAD HEIGHT - this is common for old homes.*

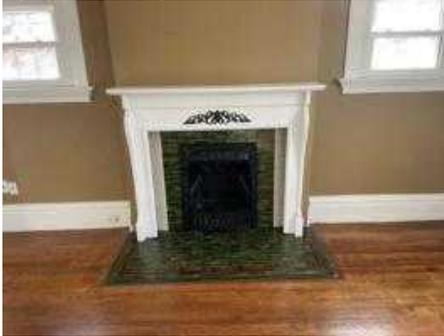
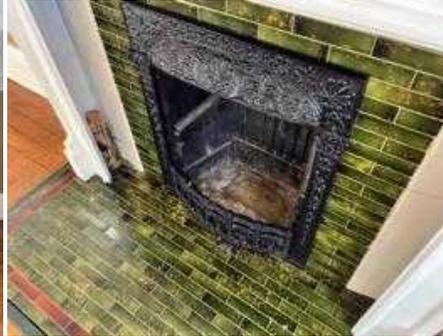
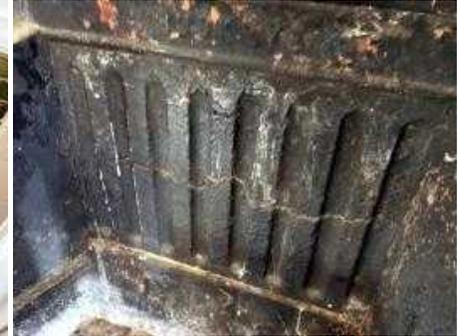
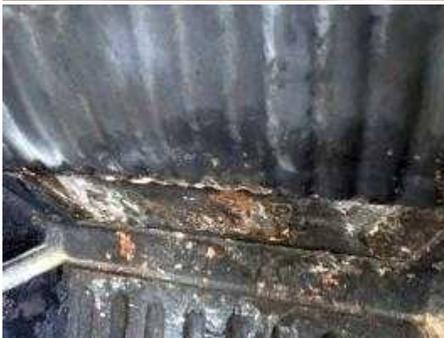
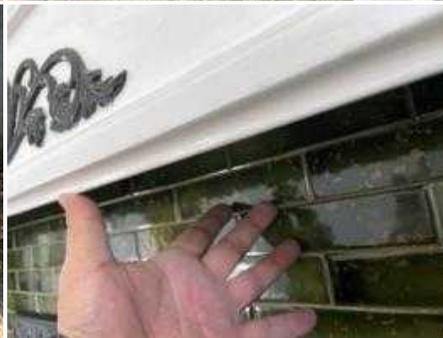
- 23. Living Room Fireplace Fireplace Type:** *A qualified contractor is recommended to evaluate and estimate repairs to operate the fireplace safely. Damaged was observed. Improper clearance to combustibles. Damper inoperative. Allow for repairs and replacements.*

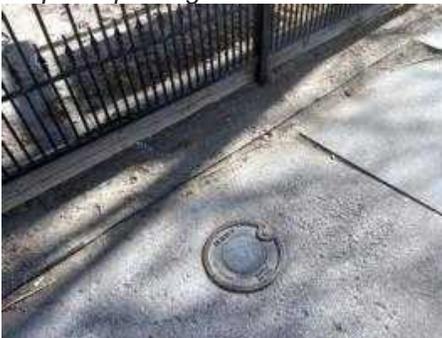
7. **Service Line:** *Not Visible Galvanized supply piping corrodes from inside causing decreased flow rates and will eventually require updating*

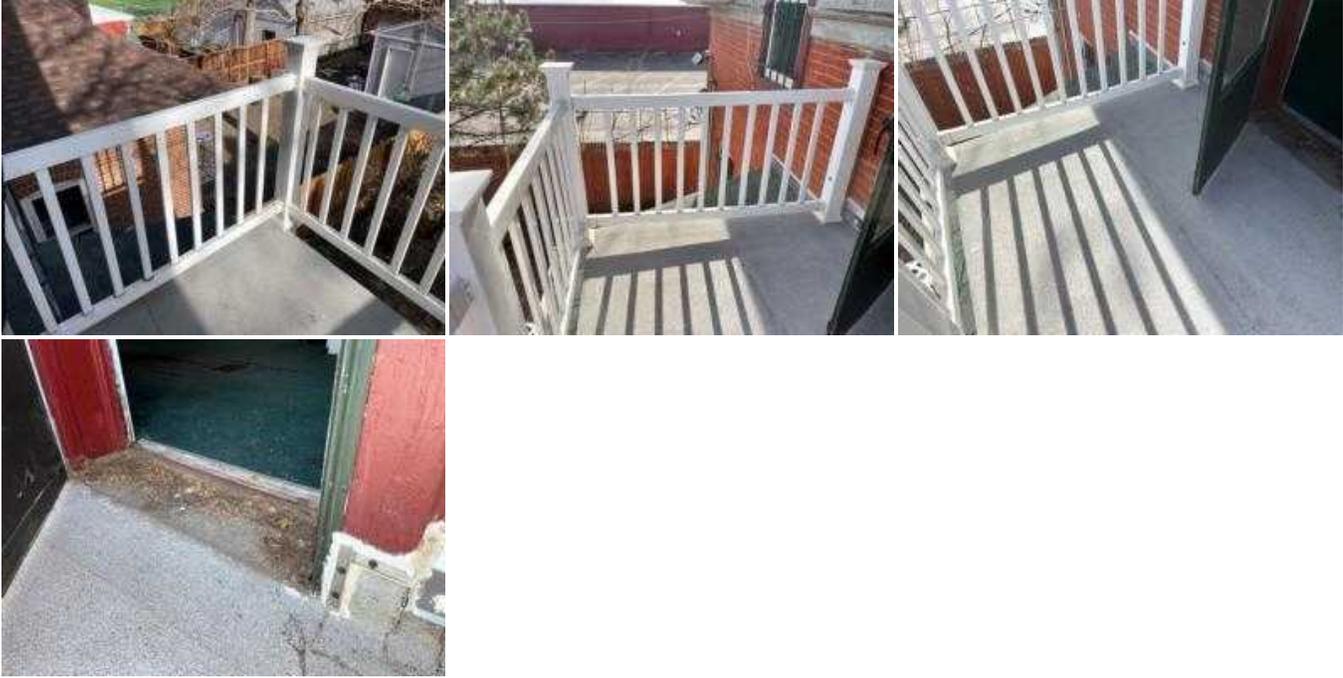
8. **Balcony:** *AGING STUCTURE - The deck is noticeably aging and a deck tune-up is recommended. Allow for repairs or replacement. Typical flaws, weathering and rot were observed but do not appear to be impacting the integrity of the deck. The deck should be properly maintained for durability and appearance. Improper installations. LEVEL WITH FLOOR - The exterior deck surface was noted as being installed at the same level as the interior floor level. This can allow for conditions conducive of moisture intrusion under the door threshold that can damage the underlying structural materials and interior finished surfaces. Loose railings should be repaired or replaced for improved safety.*

A qualified contractor is recommended to evaluate and estimate repairs, The owner should be consulted regarding permits obtained and inspection made.

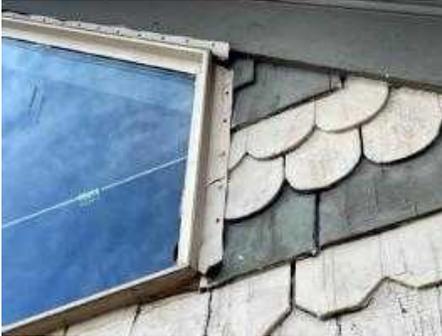
9. **Windows:** *Loft Poor install, A qualified contractor should further evaluate the windows and suggest repairs or replacement as necessary.*

Installing replacement windows would be a logical long term improvement.

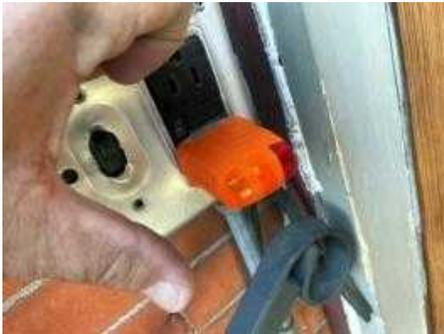
10. **GFCI Protection:** *NOT PRESENT AS REQUIRED, this should be investigated and repairs made for safety and function.*

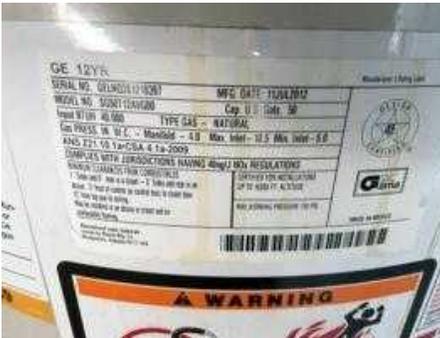
- 2. Basement Water Heater Approximate Age:** *9 years old OLDER SYSTEM - Given the age, it may require a higher level of maintenance. You should reserve funds for component replacement or failure.*

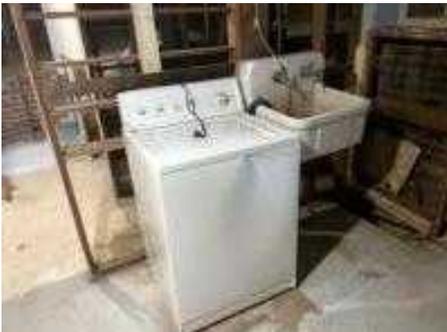
6. Basement Laundry Room/Area **OVER ALL CONDITION:** *Older components, updating would be a logical improvement. MAKESHIFT INSTALLATION*

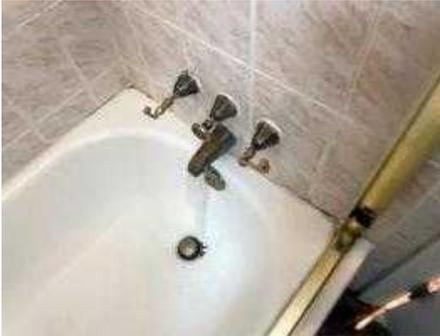
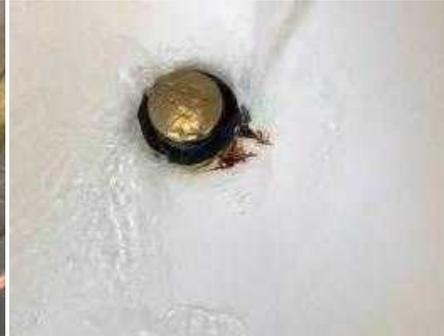
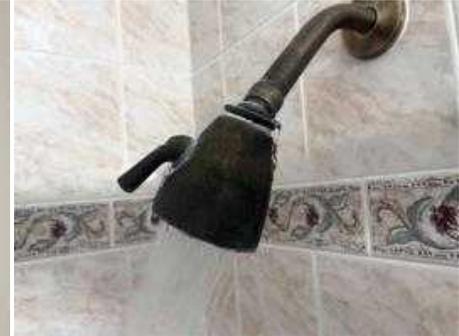
7. 1st floor- Bathroom Tub/Surround: *Porcelain tub and tile surround OLD COMPONENTS, updating would be a logical long-term improvement, GROUT loose or missing, this should be investigated and repaired as necessary. CHIPPED, damaged or rusting tub, allow for repairs*

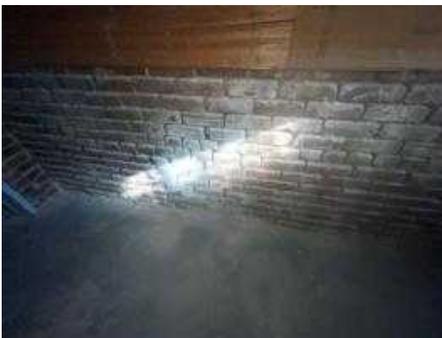
Foundation: Brick REPAIR:

DAMAGED AND DETERIORATED - The brick foundations has mortar damage and deterioration. Allow for repair or replacement. This is a common maintenance task for masonry is repair of mortar joints. The longevity of mortar joints will vary with the exposure conditions and the mortar materials used, but a life-span of more than 25 years is typical. Re-pointing and parging deteriorated mortar joints is one of the most effective and permanent ways of decreasing water entry into brick. This is because the most common means of water entry into a brick wall is through de-bonded, cracked or deteriorated mortar joints.

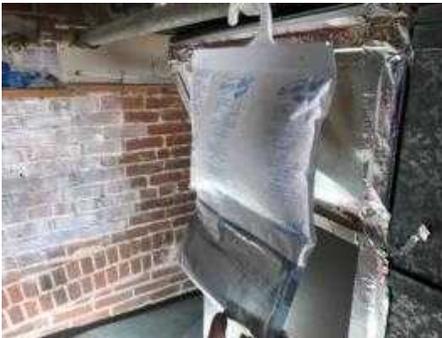
Moisture Penetration: IMPROVE:

PRIOR MOISTURE - PRESENTLY DRY - The owner should be consulted regarding prior moisture. This condition may vary seasonally and/or with precipitation intensity. Roof and lot drainage repairs or improvements should be addressed as a first step to controlling moisture. This condition should then be monitored to determine if additional measures are necessary to protect the building interior from moisture., OLD HOMES USUALLY LEAK - For owners of many old homes, basement leakage is a way of life. During rainy periods, or during the spring thaw, leakage is experienced. As basement leakage rarely influences the structural integrity of a home, and because basements of old homes usually remain unfinished, this condition is simply tolerated. Some precautions are, of course, taken to avoid damage to storage and personal belongings. If basement leakage persists, the installation of effective drainage systems (and sump pumps, in some cases) becomes necessary.

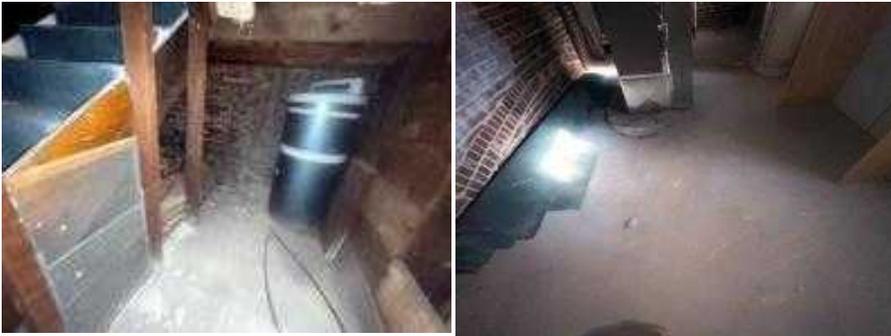
OUT OF LEVEL SLAB - The concrete slab, in some locations, is uneven. This is usually the result of movement or installation methods of the builder. The out of level slab does not appear to be affecting any other component of the home. In the absence of any sign of ongoing movement, repair should not be necessary. Out of level slabs are very common and are not normally a structural concern.

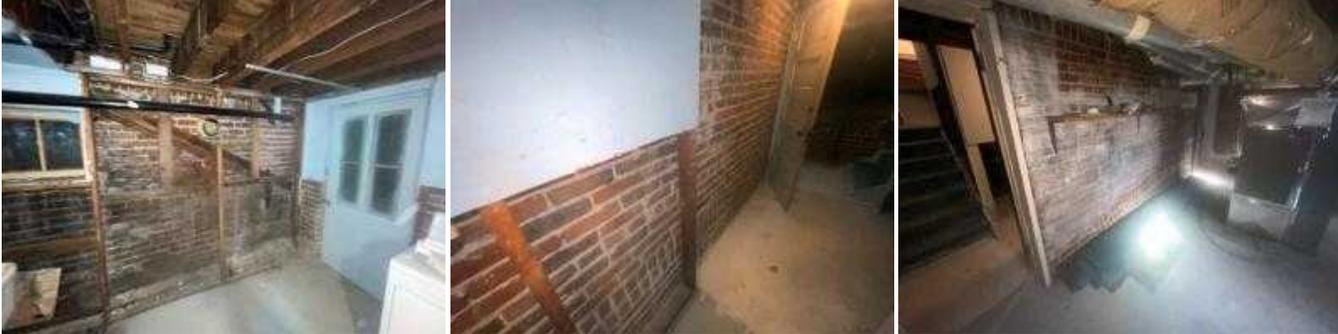
Walls: *Brick REPAIR:*

CRACKS TUCK-POINTED - in some areas, bricks were sealed by tuck-pointing. This is a common maintenance task for masonry is repair of mortar joints. The longevity of mortar joints will vary with the exposure conditions and the mortar materials used, but a life-span of more than 25 years is typical. The longevity of brick, however, may exceed 100 years. Consequently, occasional repair of the mortar joints is expected over the life of the material. It is our observation that the most common reason for re-pointing masonry is to improve water penetration resistance. Re-pointing and parging deteriorated mortar joints is one of the most effective and permanent ways of decreasing water entry into brick. This is because the most common means of water entry into a brick wall is through de-bonded, cracked or deteriorated mortar joints.

TUCK-POINTING IS RECOMMENED - brick joints should be properly sealed.

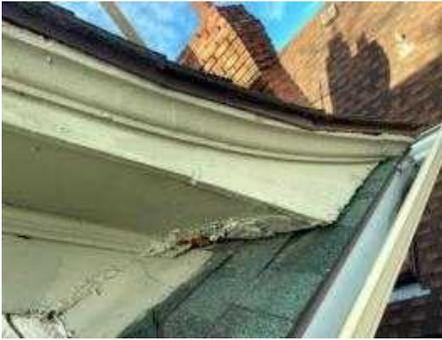
Valleys: *IMPROVE:*

A qualified roofing contractor is recommended to evaluate and estimate repairs

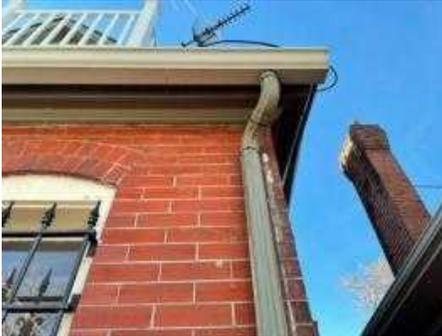
Downspouts: APPEARS SERVICABLE:

Downspouts appear to be properly installed and performing as intended. This should be monitored and improved as necessary.

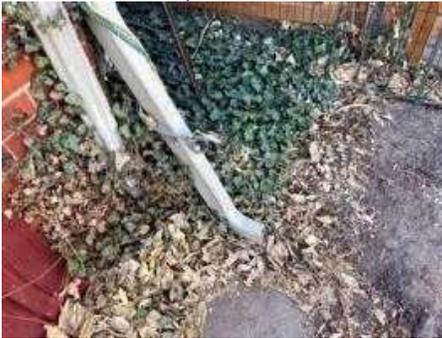
Leader/Extension: IMPROVE:

Downspout extension do not discharge 6 feet beyond the foundation

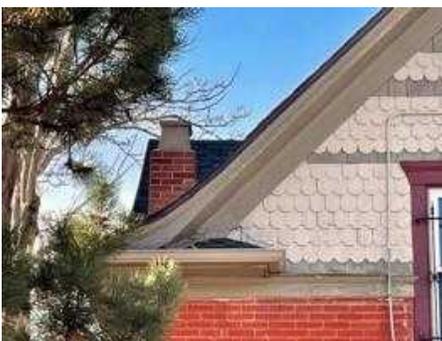
Chimney: Brick REPAIR:

EVLAUATION - by a qualified contractor is recommended and estimate repairs, A chimney was not entirely visible during the inspection of the roofing system.

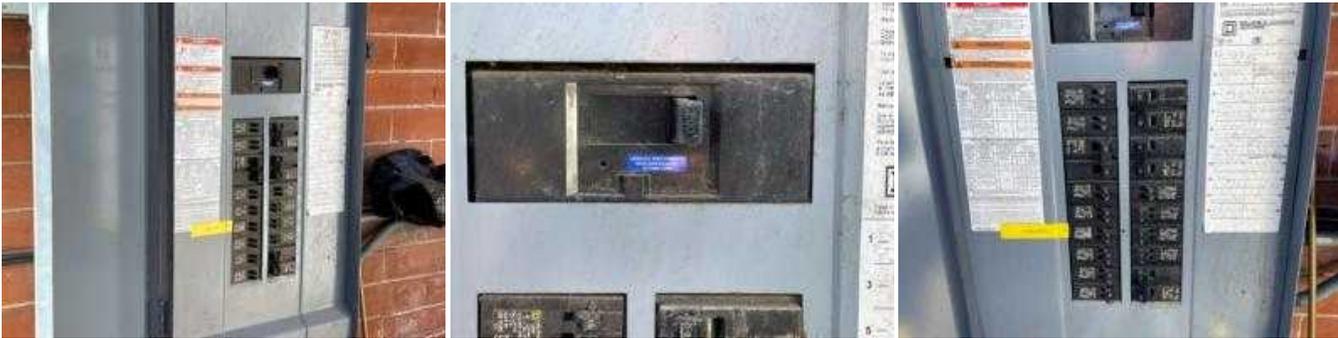
Exterior back of home Electric Panel

Manufacturer: Square D APPEARS SERVICABLE:

NEWER OR REPLACED PANEL - The owner should provide all documentation, permits and inspections. Verify that the wires and breakers are properly sized for the device and breakers that they serve.

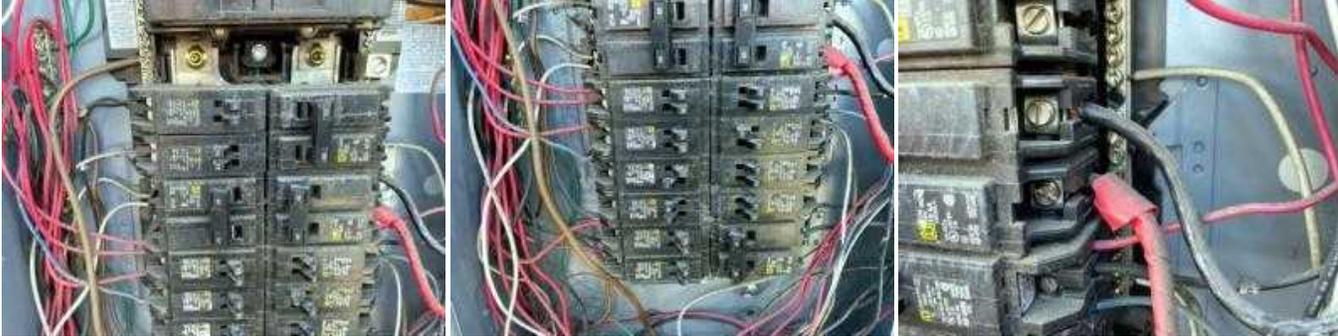
Breakers: *Copper APPEARS SERVICABLE:*

The breakers appeared to be functional and properly installed but were not tested or tripped.

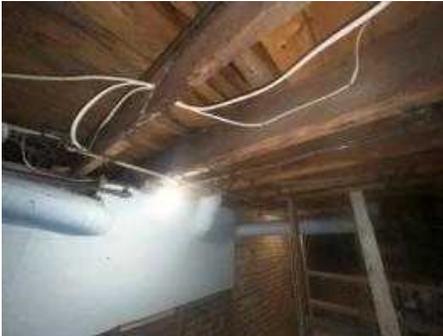
Conductor Type: *IMPROVE:*

OLDER WIRE PRESENT - Evaluation by a qualified electrician is recommended.

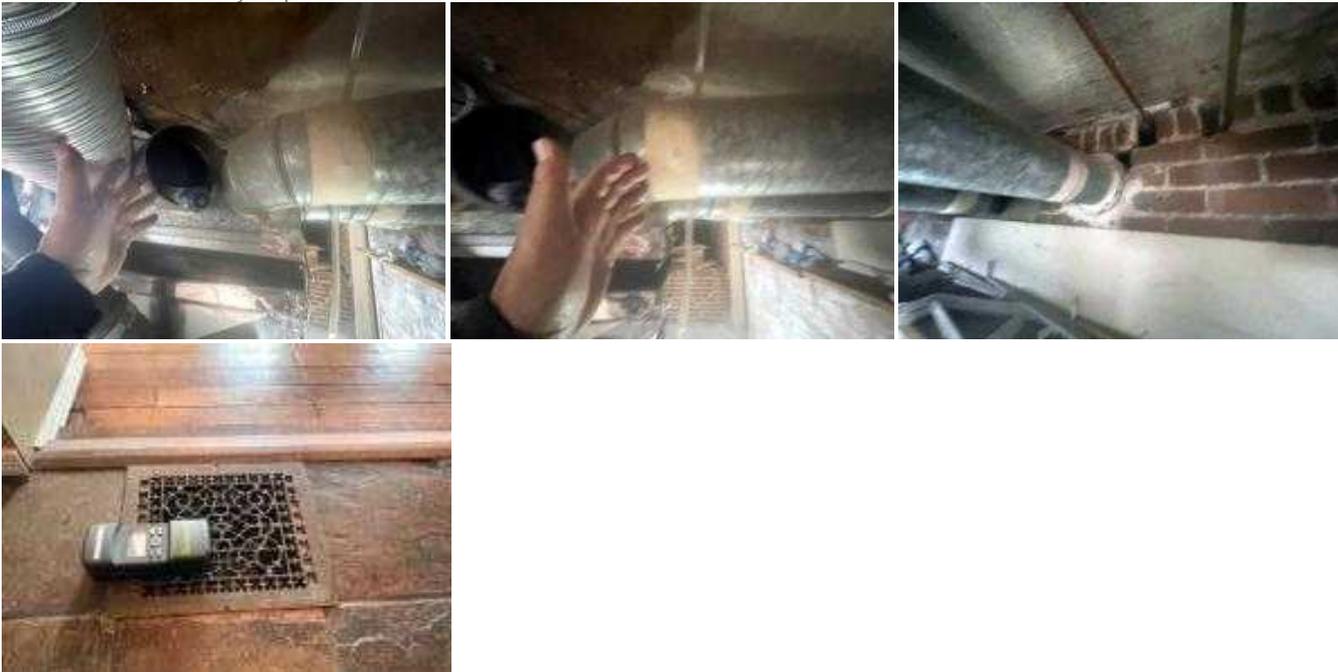
Ductwork not ideally configured. This may inhibit heat distribution and may not be conducive to proper distribution of cool air, if air conditioning is employed. ACM - Possible asbestos containing materials (ACM) on ducts. This should be investigated and improvements made for safety and function.

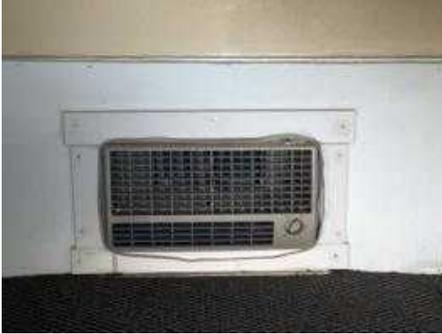
SHUTOFF - The system appears to be disconnected. A qualified technician should restore the unit to working condition and verify that the system is operating properly., FURTHER EVALUATION - A qualified technician should restore the unit to working condition and verify that the system is operating properly.

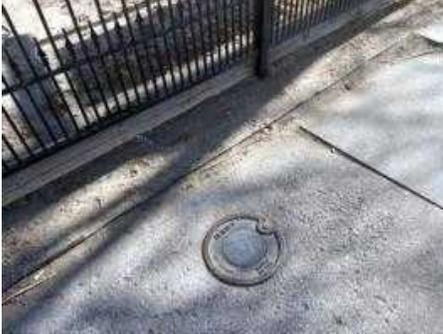
Galvanized supply piping corrodes from inside causing decreased flow rates and will eventually require updating

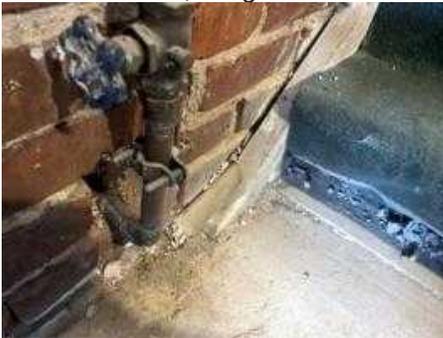
The visible water supply piping was in satisfactory condition and was functioning as designed and intended. The water shutoff valves appeared to be in serviceable condition at the time of the inspection. They were not operated but were visually inspected. OLD SHUTOFF VALVE(S) - Upgrading valves would be a logical long-term improvement. In the interim, a higher level of maintenance will likely be required. The valves were not operated.

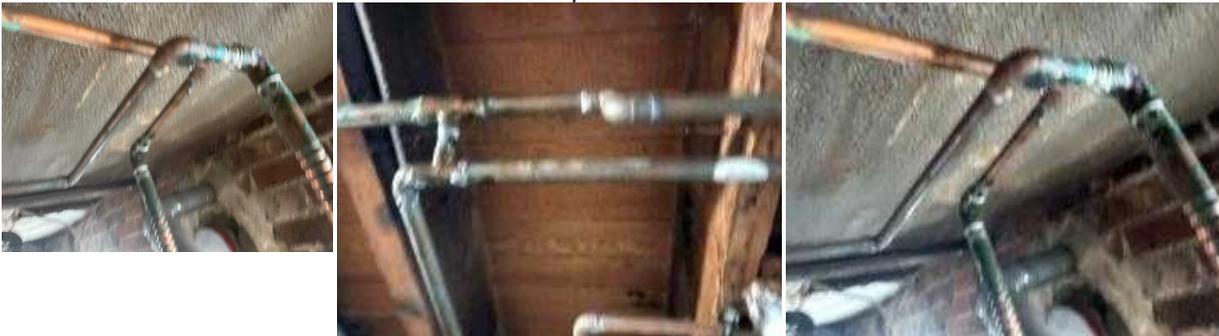
The potable water pipes, where visible appear to be in satisfactory condition.

Small diameter water lines should be improved.

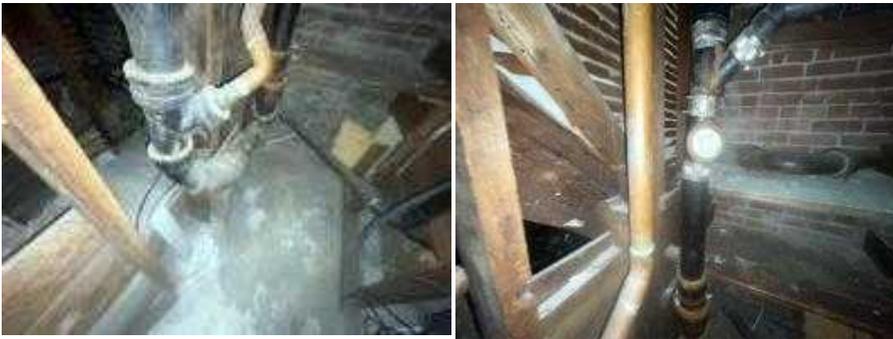
CLEAN AND RE-SCOPE - the waste line of the home should be further evaluated after cleaning, repair may be needed (see the sewer scope report for details).

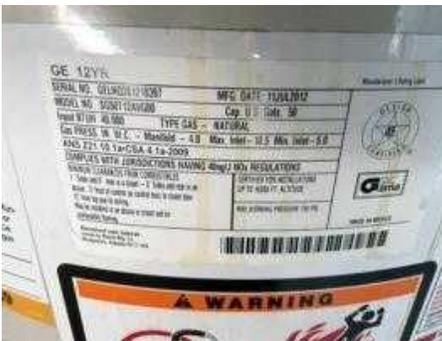
OLDER SYSTEM - Given the age, it may require a higher level of maintenance. You should reserve funds for component replacement or failure.

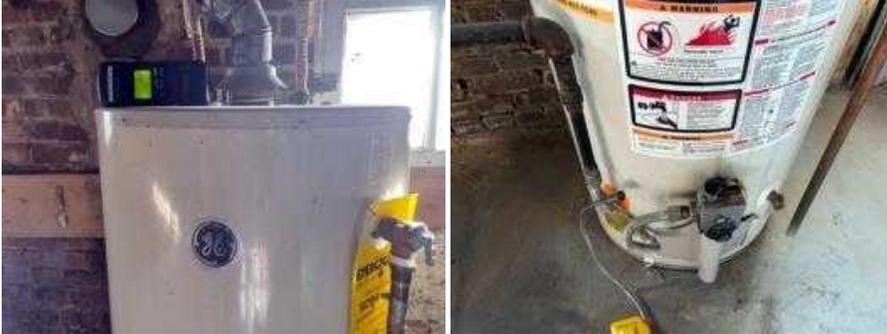
OLDER UNIT - Water heater is nearing the end of it's design life, it would be wise to budget for a new unit

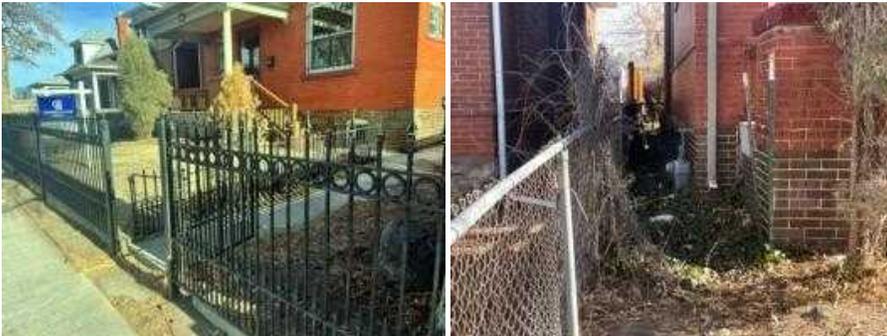
LACKING MAINTENANCE - The property has lacked some maintenance; repairs are needed.

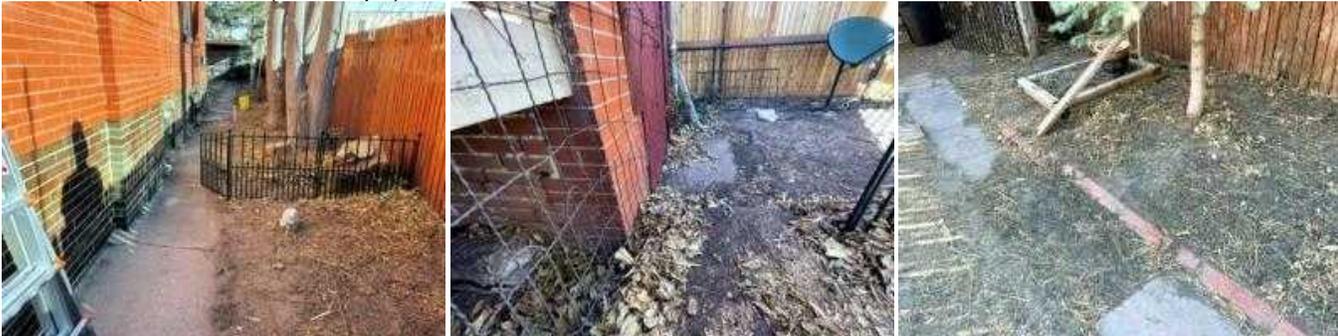
GRADING SHOULD BE IMPROVED - to promote the flow of storm water away from the house. Ideally, the ground should slope away from the house at a rate of one inch per foot for at least the first ten feet. At least eight (8) inches of clearance should be maintained between soil level and the bottom of exterior wall siding. You keep dry landscaping or drought tolerant landscaping without irrigation (also called 'Xeriscape') for at least the first 5 feet around the house (more if there are signs of expansive soil problems).

Recommend improvements be made to the grade, swale slope and depth to improve water control, Planting beds have been constructed near the foundation walls. Water for plants will eventually soak into soil and may reach the foundation. Excessive moisture content in soil supporting the foundation can cause foundation and other structural damage from undermining, heaving or settling, depending on soil composition, moisture content and other conditions. We recommend removal of any planting beds near the foundation or re-planting with vegetation which has low water requirements (Xeriscape).

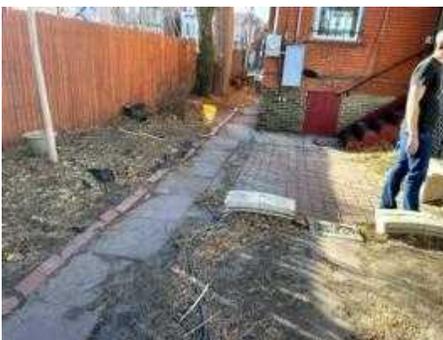
TYPICAL CRACKS AND DISPLACEMENT - The flatwork is cracked and has settled and/or heaved. Persisting movement may result in the need for resurfacing. All openings in the slabs should be sealed to minimize moisture penetration. Cracks and unevenness more than 1/8 high could present a trip hazard.

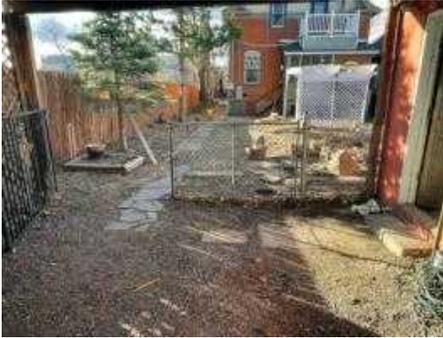
SURFACING the driveway would be a logical long term improvement.

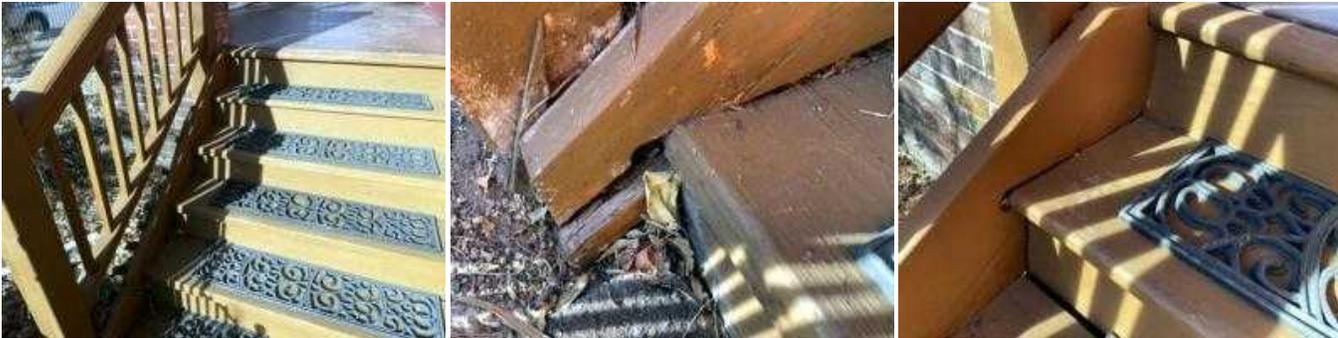
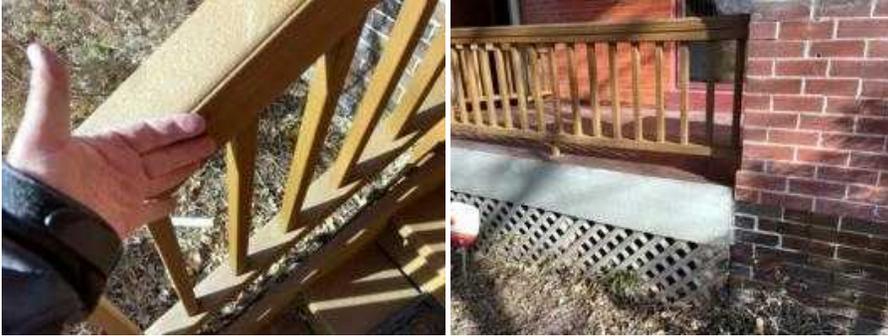
FRAMING - POOR installations, STAIRS OR STEPS Damaged. Allow for replacements.

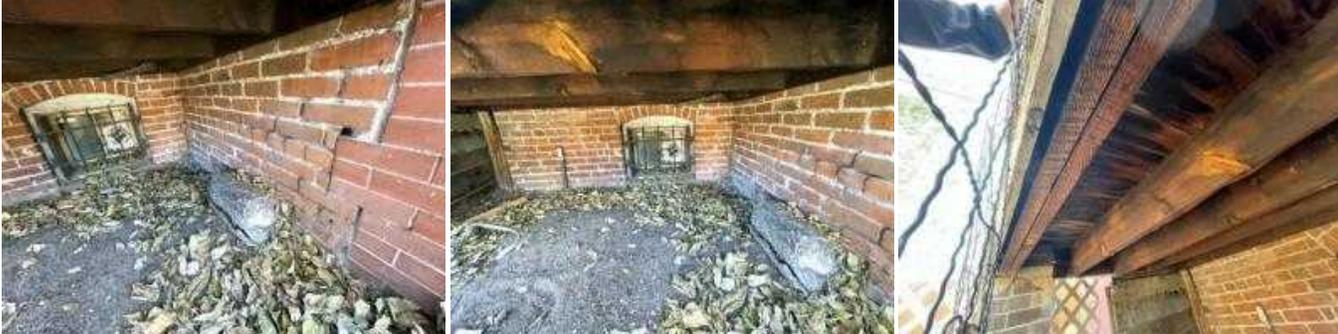
WEATHERED AND COMMON ROT - The deck framing is showing signs of age. Localized rot was observed., Unable to inspect the underside. Allow for repairs as necessary for durability and appearance. Damaged or rotted material that is discovered should be replaced. Improper connections or support should be improved. Any soil contact with the wood should be eliminated.

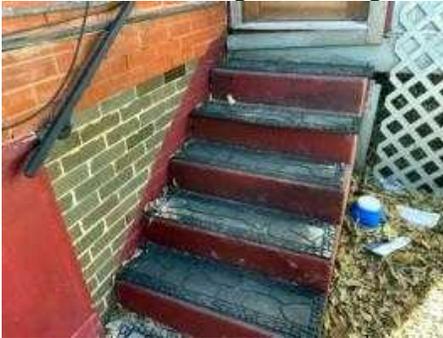
Stairs/Railings: *Damaged SAFETY ISSUE:*
The missing stair railing should be installed

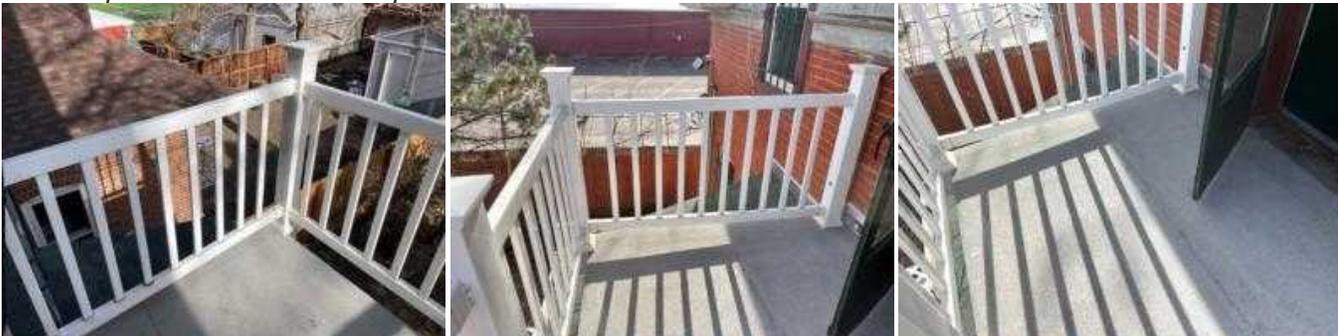
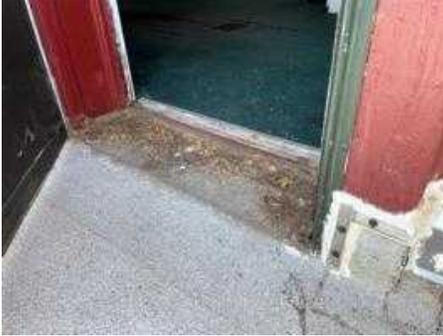
AGING STRUCTURE - *The deck is noticeably aging and a deck tune-up is recommended. Allow for repairs or replacement. Typical flaws, weathering and rot were observed but do not appear to be impacting the integrity of the deck. The deck should be properly maintained for durability and appearance. Improper installations. LEVEL WITH FLOOR* - *The exterior deck surface was noted as being installed at the same level as the interior floor level. This can allow for conditions conducive of moisture intrusion under the door threshold that can damage the underlying structural materials and interior finished surfaces. Loose railings should be repaired or replaced for improved safety.*

A qualified contractor is recommended to evaluate and estimate repairs, The owner should be consulted regarding permits obtained and inspection made.

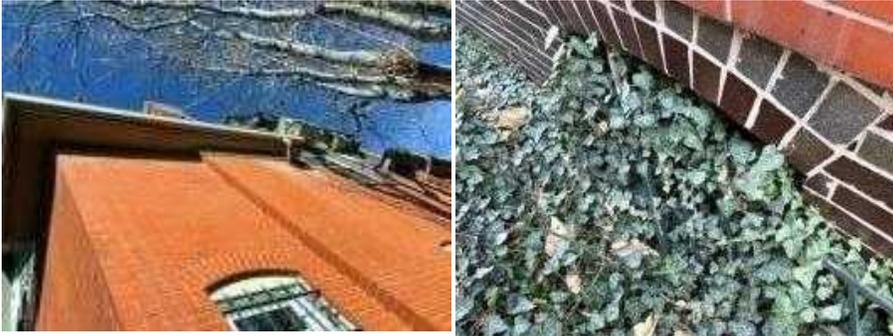
FURTHER EVALUATION -by a qualified arborist is recommended, TREES TOO CLOSE TO HOME - may cause damage to the foundation or other components of the property. This should be investigated. Removing may become necessary., PLANTS TOO CLOSE TO HOME - Vegetation should be trimmed or removed.

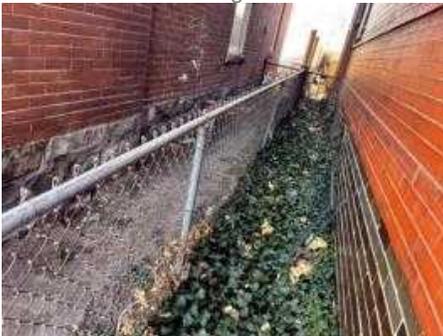
A qualified contractor is recommended to evaluate and estimate repairs, WEATHERED - Staining is recommended for improved appearance and durability., POST(S) DAMAGED - should be repaired or replaced, LOW QUALITY - replacement would be a logical improvement

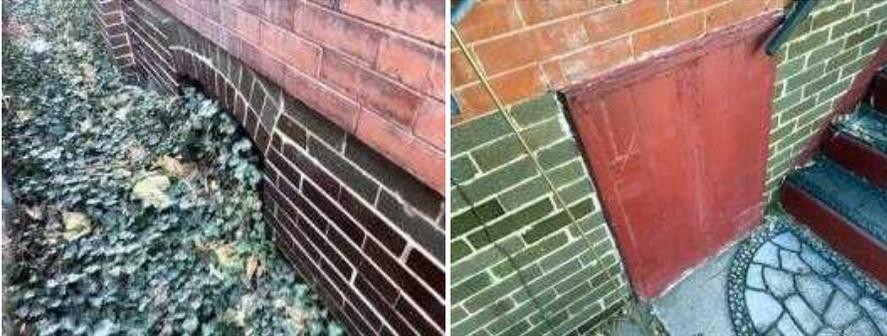
MISSING - Window wells should be installed to protect the home from moisture penetration. IMPROVE GRADING - to minimize moisture penetration.

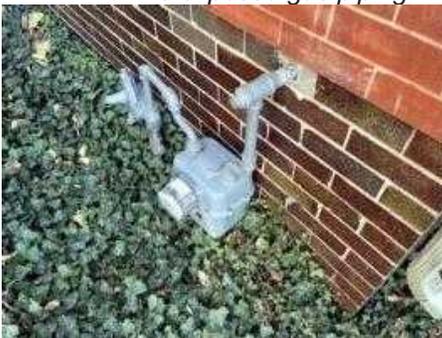
Gas Meter: *Exterior surface mount at the left side of home APPEARS SERVICABLE:*

The meter was in acceptable condition, properly installed and supported. No evidence of leakage was detected at any of the exposed gas piping.

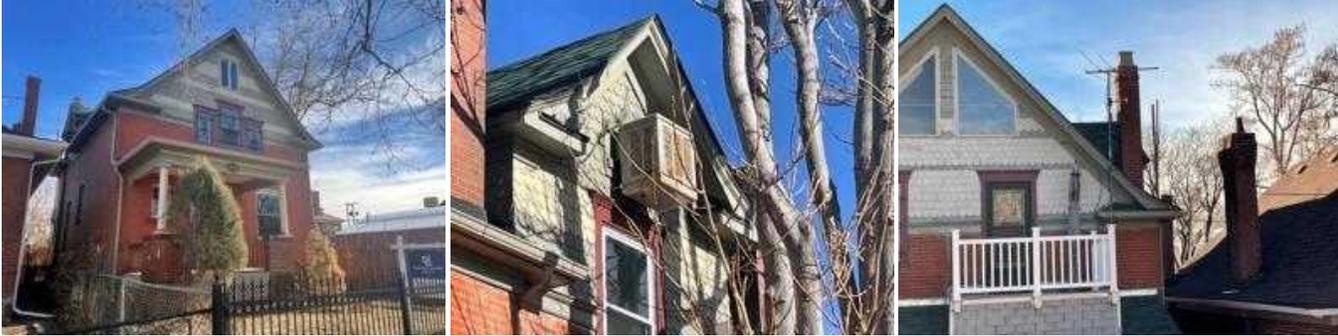
The exterior of the home shows normal wear and tear for a home of this age., The exterior of the home has lacked some maintenance; repairs are needed.
