Professional Building Inspection Service
11757 W Ken Caryl Ave, F-219 - Littleton - CO - 80127
303-346-2250 - www.InspectProLLC.com

123 Main St, Any Where

Date Inspected:
December 44, 2099

Prepared for Our Client:
John and Jane Doe

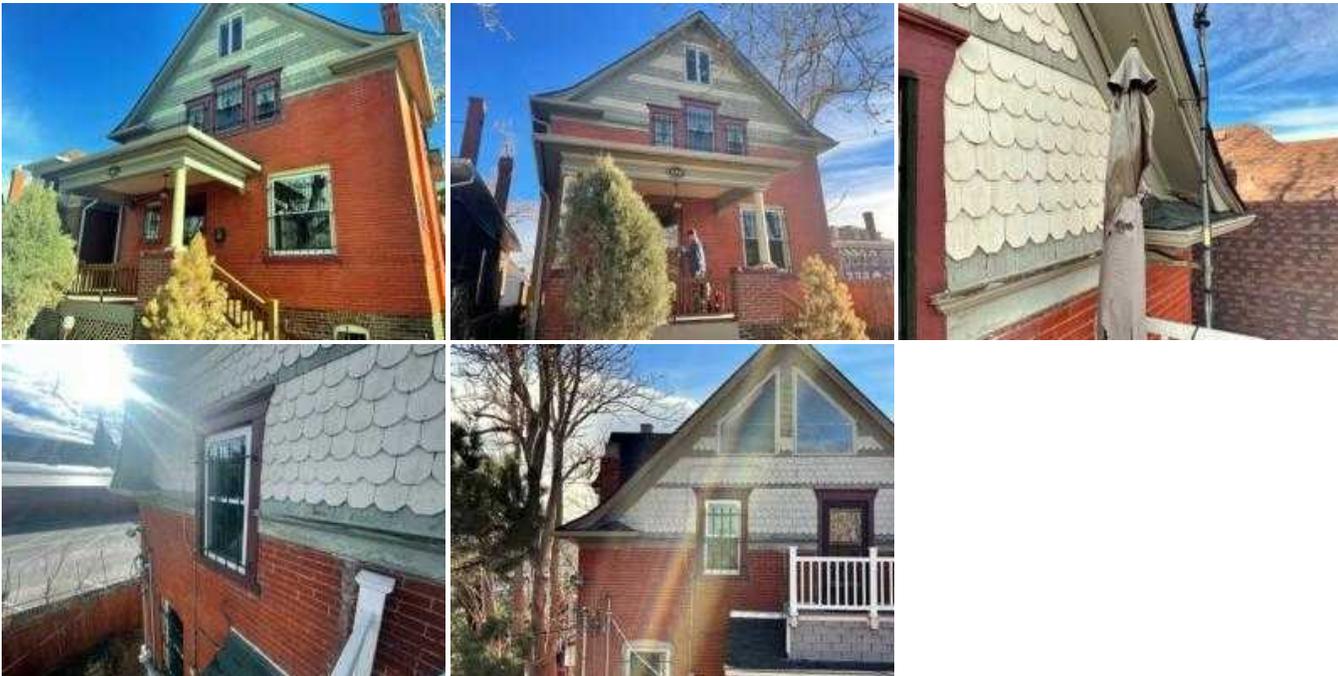
NORMAL WEAR AND TEAR - The siding and trim is showing signs of age but appears to be performing as intended. Regular maintenance of caulking and painting all joints, penetrations and fasteners is imperative to reduce damage.

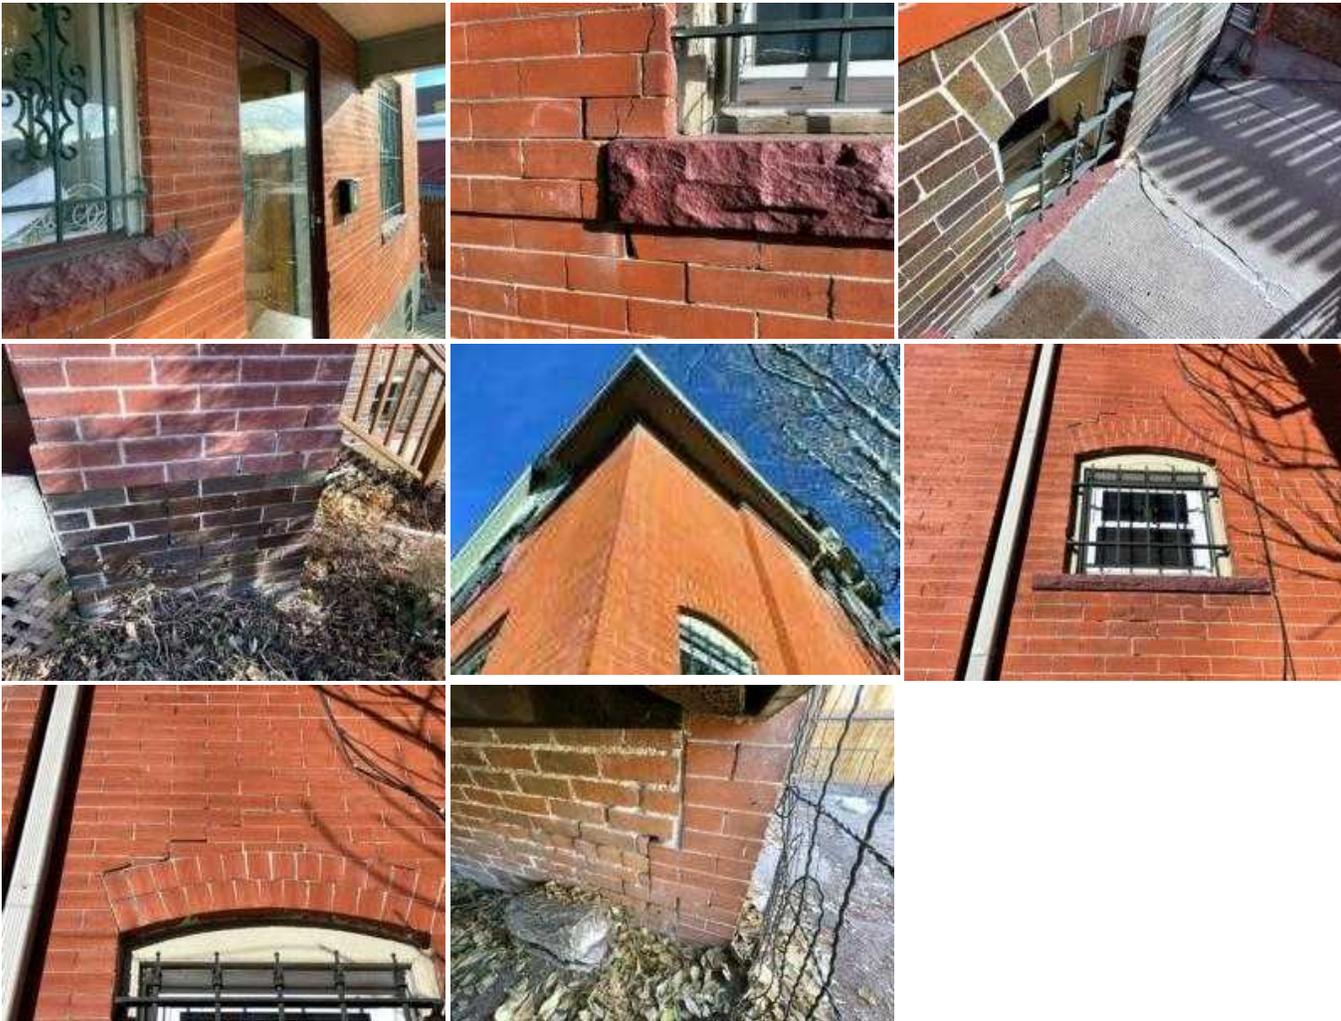
Common minor cracks were observed on the exterior walls of the house. Allow for sealing and tuck point improvements, Localized pointing of deteriorated mortar is advisable to prevent further deterioration and moisture penetration, Gaps should be properly sealed., Typical surface flaws and deterioration. Allow for improvements.

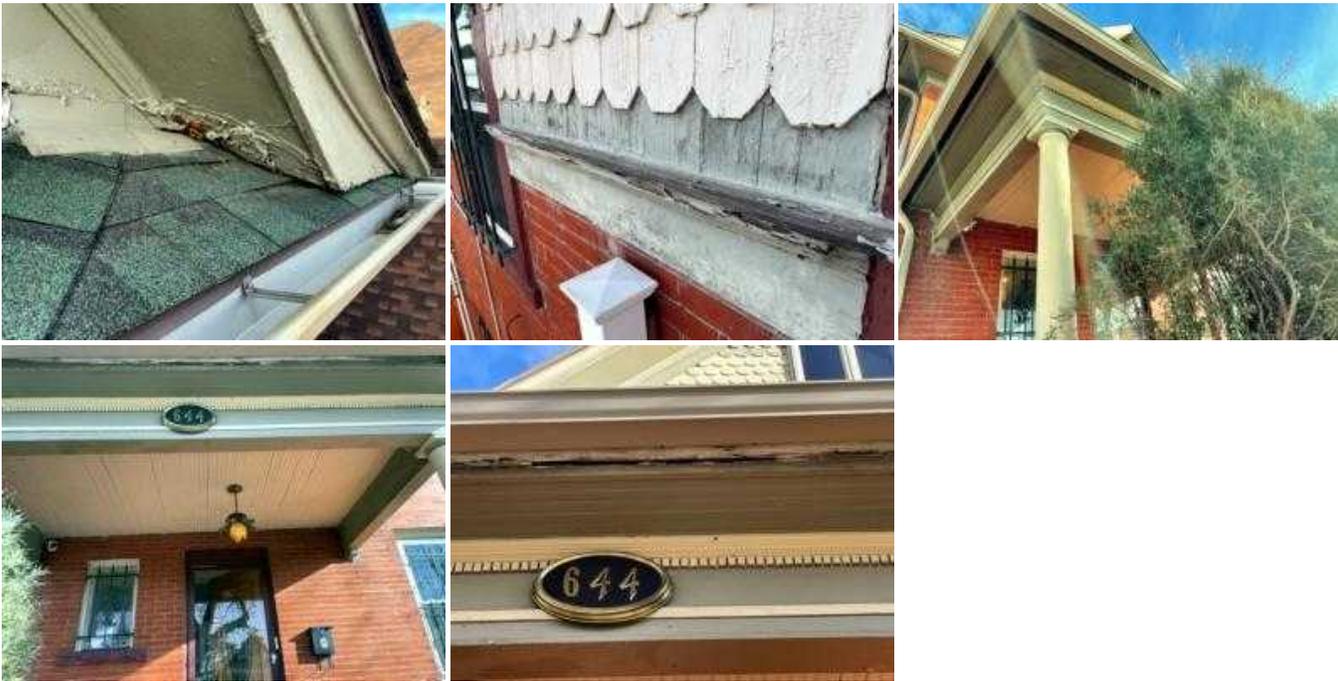
WEATHERED AND WORN - The wood trim is aging and is noticeably worn. Allow for repairs or replacement., GAPS - should be properly sealed, caulking and sealing is recommended, PAINT PEALING - these areas should be painted and sealed., DAMAGED MATERIALS should be repaired or replaced.

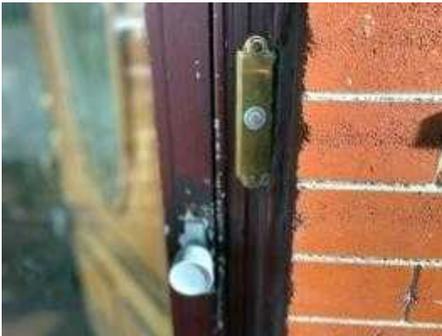
Damaged material should be repaired, Gaps should be sealed, caulking and sealing is recommended

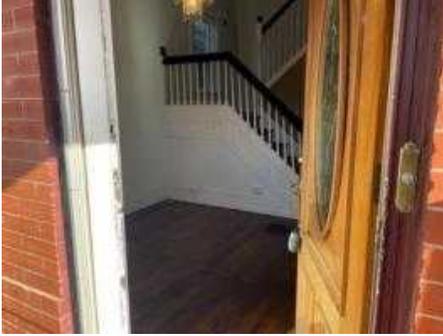
Weather seal improvements is recommended, Adjustment needed for improved operation., SCUFFED AND SCRATCHED.

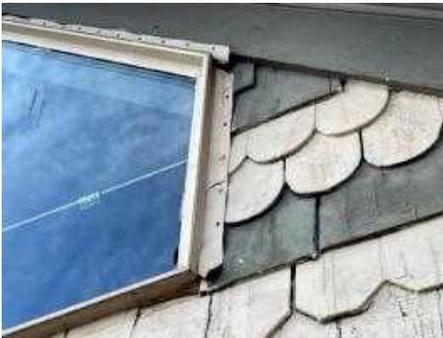
Poor install, A qualified contractor should further evaluate the windows and suggest repairs or replacement as necessary.

Installing replacement windows would be a logical long term improvement.

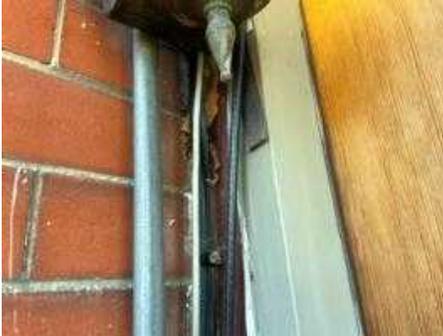
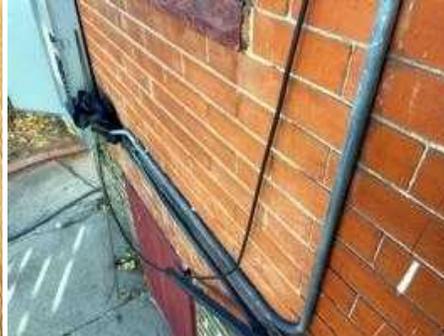
EXPOSED OR SURFACE WIRE - should be protected or relocated

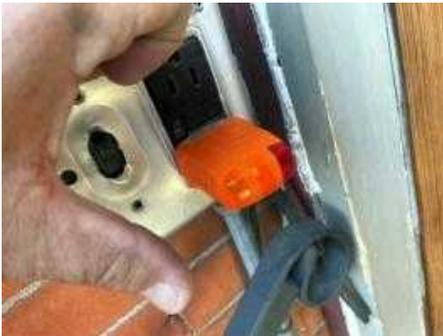
NOT PRESENT AS REQUIRED, this should be investigated and repairs made for safety and function.

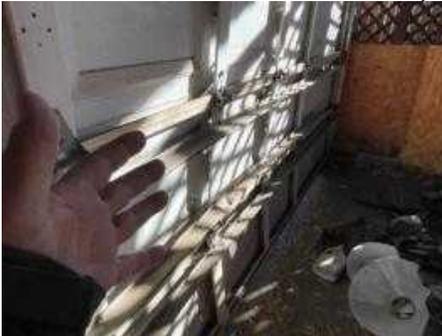
AGING NOTICABLY - replacement would be a logical long-term improvement

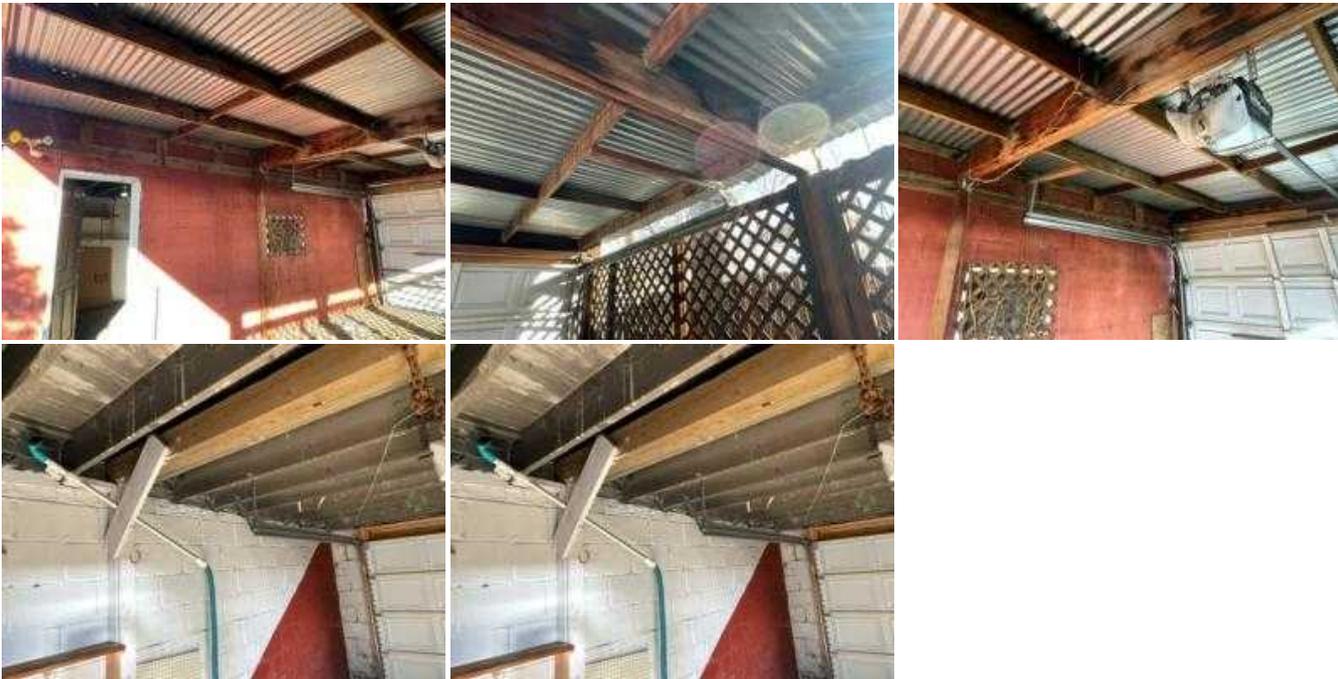
OLD FRAMING - The roof framing in this old home is typical for most of the structures in the area which have function satisfactorily for decades. Due to the depth to span ratios, the age of construction and the observed roof rafters, it is unlikely that the framing could support the snow loading requirements found in today's codes. However, with repairs made to any damaged rafters and minor modification to the existing framing, the roof system could still function in an acceptable manner., Fire/smoke mitigation observed. The owner should be consulted regarding repairs made., A structural engineer is recommended to evaluate and estimate repairs

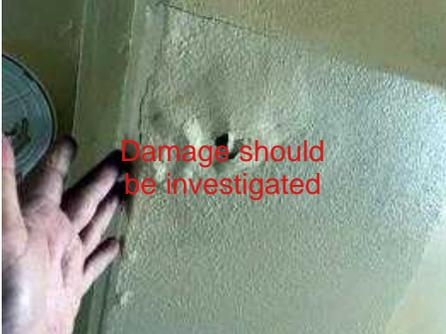
Ceiling: *Drywall APPEARS SERVICABLE; IMPROVE:
HEAD HEIGHT - is too low by today's standards.*

CRACKING was observed. In the absence of any additional movement only cosmetic repairs will be necessary. This should be investigated. STAINS - Were noted while investigating the ceiling. The owner should be consulted. This should be investigated and damaged materials should be properly restored. , DAMAGE to interior finishes, STAINS - Were noted while investigating the ceiling. The owner should be consulted. This should be investigated and damaged materials should be properly restored.

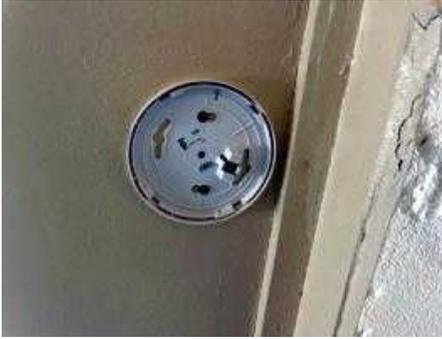
Smoke Detector: SAFETY ISSUE:
MISSING detector should be replaced.

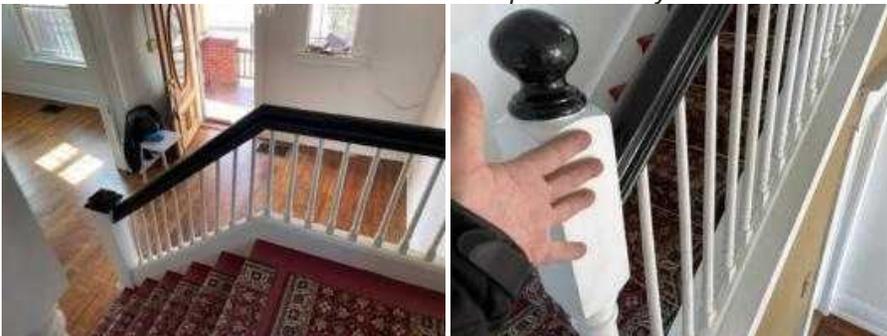
Walls: Loose railing IMPROVE:

TYPICAL FLAWS were observed in the finishes. Allow for improvements., BALUSTER SPACING TOO WIDE - although this may have been allowed when this was installed, it has improper spacing by today's standards. Allow for improvements. The openings in the stairway railing are large enough to allow a child to fall through. It is recommended that this condition be altered for improved safety.

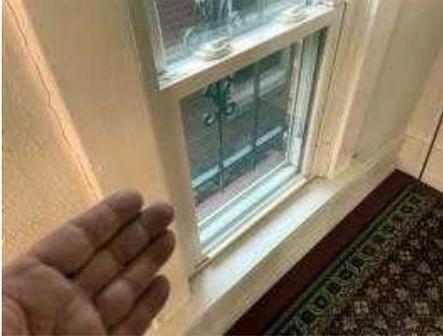
NOT TEMPERED - glass does not appear to be tempered or safety glass, allow for replacement. All glass installed in a shower surround or shower door must be tempered or safety glazing.

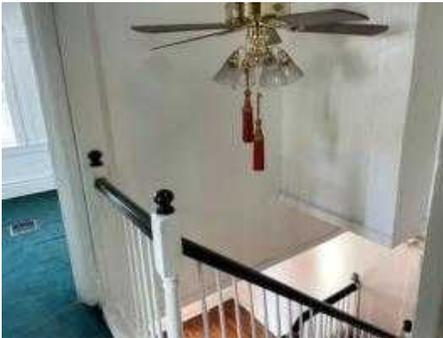
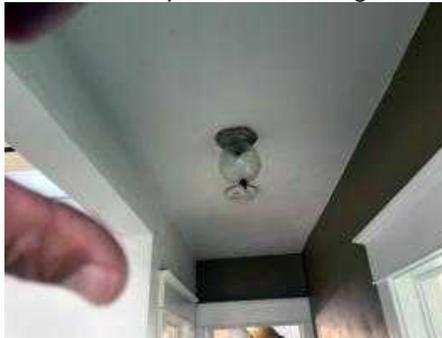
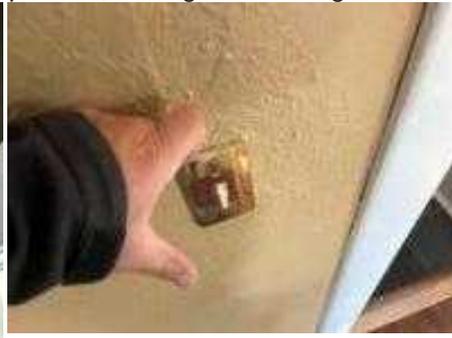
LIGHT INOPERATIVE - or that does not respond to controls are presumed to have burned out lamps. Dismantling fixtures to confirm the status of bulbs is not performed during our inspection., Ceiling fan low height

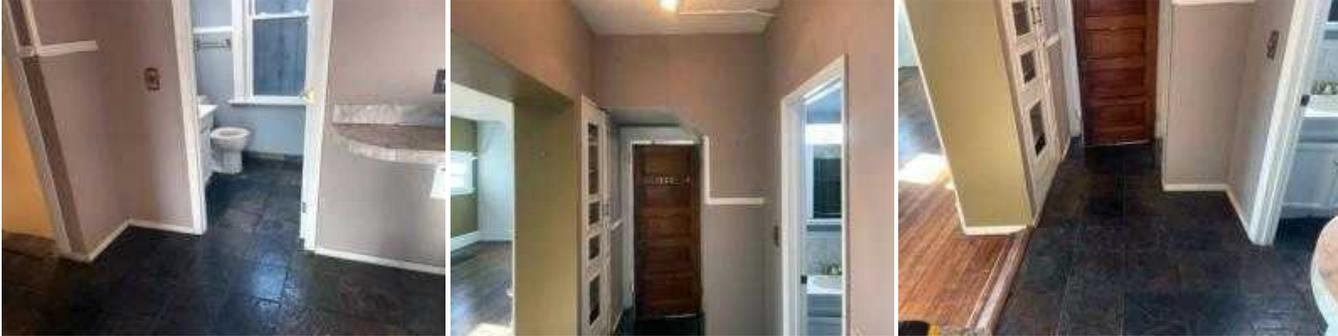
CRACKS was observed. In the absence of any additional movement only cosmetic repairs will be necessary. This should be investigated.

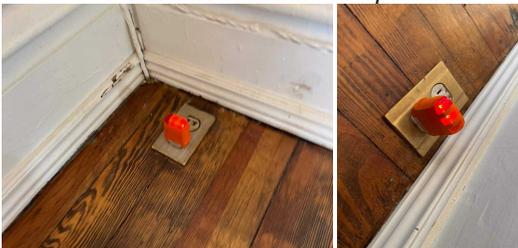
FLOOR OUTETS should be investigated - proper outlets may be desirable where plastic outlets exist. *REVERSED POLARITY* outlets are present

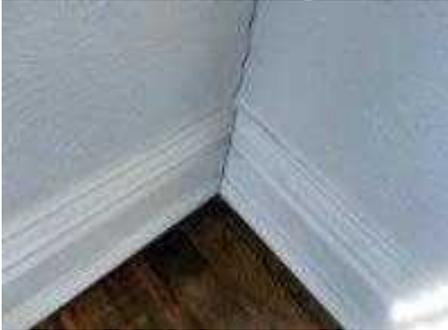
CRACKS was observed. In the absence of any additional movement only cosmetic repairs will be necessary. This should be investigated.

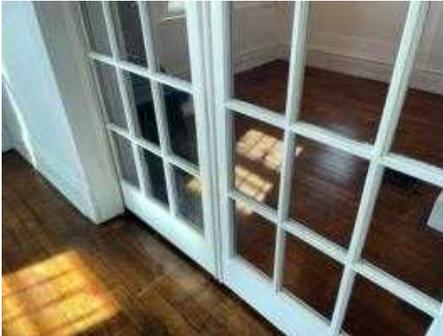
SAFETY GLASS NOT INSTALLED. Allow for improvements.

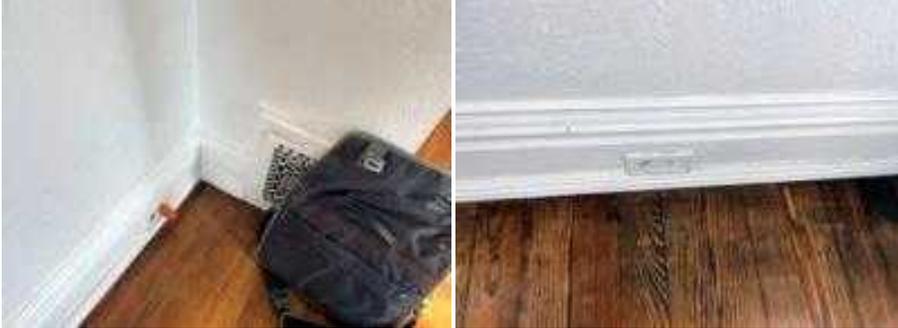
Outlets and Wiring: *Grounded and 2-Prong Ungrounded APPEARS SERVICABLE.; IMPROVE: INSUFFICIENT NUMBER - of outlets for this space. Allow for improvements.*

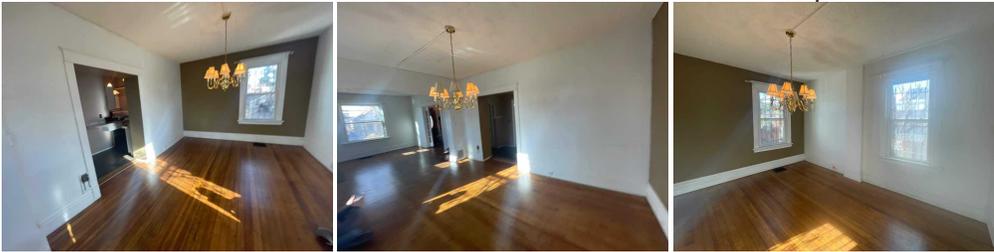
OVER ALL CONDITION: *Older components, updating would be a logical improvement., Normal wear and tear. APPEARS SERVICABLE:*

TYPICAL FLAWS were observed in the finishes. Allow for improvements.

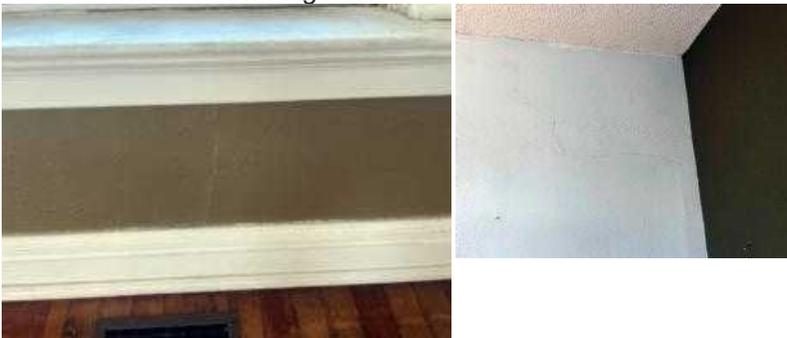
Walls: *IMPROVE:*

CRACKS was observed. In the absence of any additional movement only cosmetic repairs will be necessary. This should be investigated.

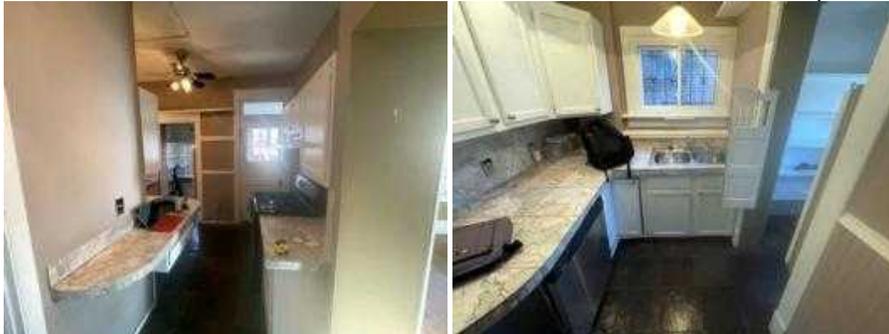
OVER ALL CONDITION: *Older components, updating would be a logical improvement., Normal wear and tear. APPEARS SERVICABLE:*

TYPICAL FLAWS were observed in the finishes. Allow for improvements.

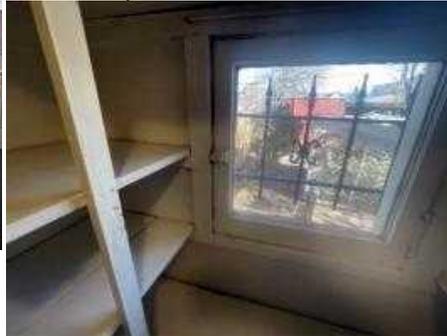
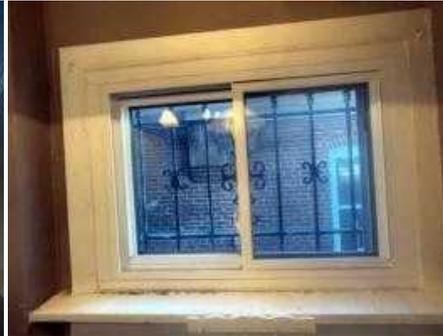
Ceiling: *APPEARS SERVICABLE.; IMPROVE:*
CRACKING was observed. In the absence of any additional movement only cosmetic repairs will be necessary. This should be investigated. TYPICAL FLAWS were observed in the finishes. Allow for improvements.

Walls: *IMPROVE:*
TYPICAL FLAWS were observed in the finishes. Allow for improvements.

Floor: *Tile APPEARS SERVICABLE:*
TYPICAL FLAWS were observed. Allow for improvements. UNEVEN floors. This is not uncommon.

Doors: *Wood and Glass APPEARS SERVICABLE.; IMPROVE:*
SAFETY GLASS NOT INSTALLED. Allow for improvements. WEATHER SEALS - should be replaced. SURFACE DAMAGED - allow for replacement.

Windows: *Old window not replaced APPEARS SERVICABLE:*
WINDOW TUNE-UP is recommended. Windows that have damaged components, frames and missing hardware should be properly restored. Missing screens should be installed. Damaged screens should be replaced. STUCK - WILL NOT OPEN, allow for repairs

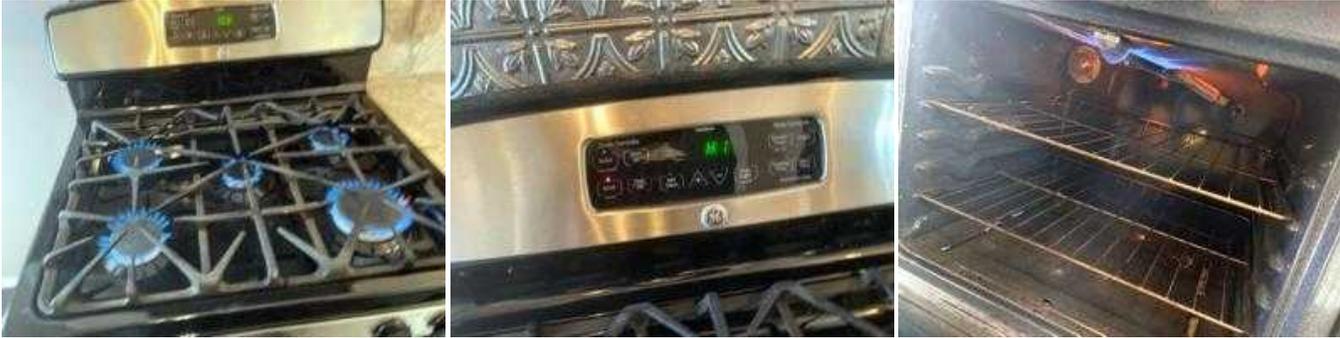
Oven/Range *Gas-, General Electric IMPROVE:*
Anti-tip device missing. Recommend an anti-tip device be installed - to prevent accidental tipping forward if heavy items are set on the oven door, All elements/burners were tested and were operational at the time of the inspection.

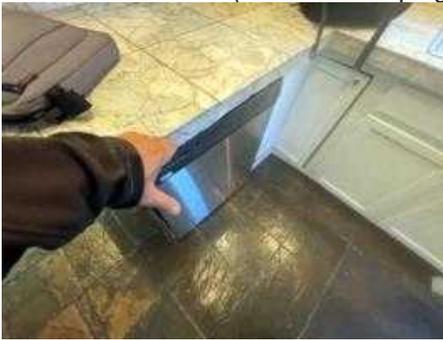
Dishwasher: Kenmore APPEARS SERVICABLE; REPAIR:

Inoperative, Dishwasher discharge line connects to disposal - although this was an accepted installation in the past it is recommended to have an air gap device installed to prevent dishwasher contamination in the event the disposal fills with water (ie - drain line plugs)

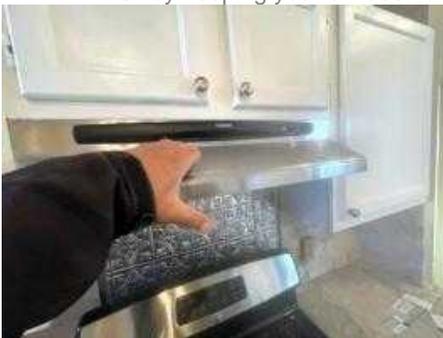
Ventilator: NuTone REPAIR:

Inoperative, Does not vent to the exterior of the home.

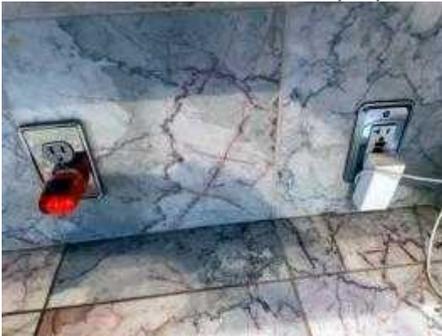
GFCI Protection: *110 VAC GFCI APPEARS SERVICABLE; SAFETY ISSUE:*

TESTED PROPERLY - the GFCI circuit was tested and operated properly at the time of the inspection. NOT PROVIDED - at all proper locations. Allow for repairs per today's good building practices

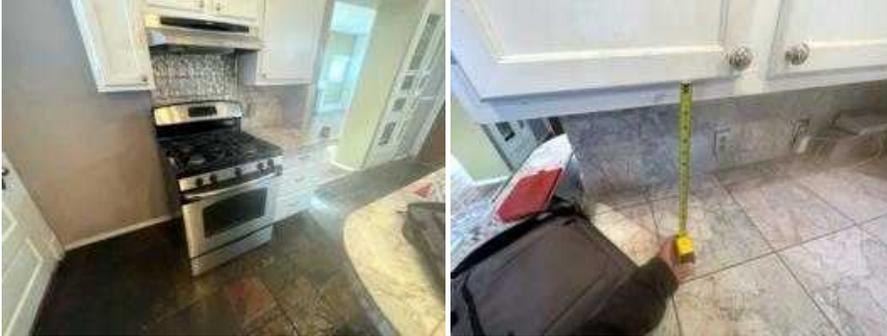
Counter Tops: *Tile, Granite IMPROVE:
OLDER - updating would be a logical improvement*

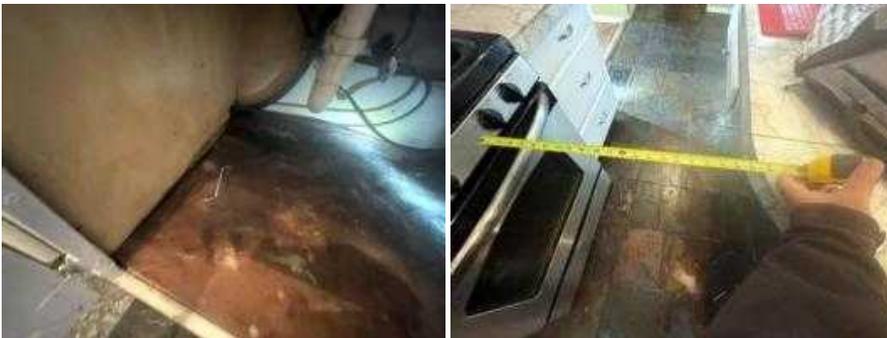
Cabinets: *Laminate and composite materials APPEARS SERVICABLE:, IMPROVE:
OLDER, updating would be a logical improvement, ADJUSTMENT NEEDED. - components should be adjusted for improved appearance and operation. SURFACE DAMAGE - laminate loose or peeling. Narrow clearances should be improved.*

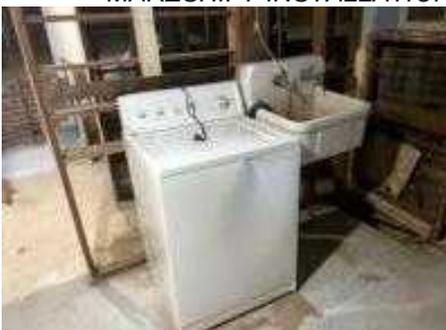
OVER ALL CONDITION: *Older components, updating would be a logical improvement. DEFERRED COST:
MAKESHIFT INSTALLATION*

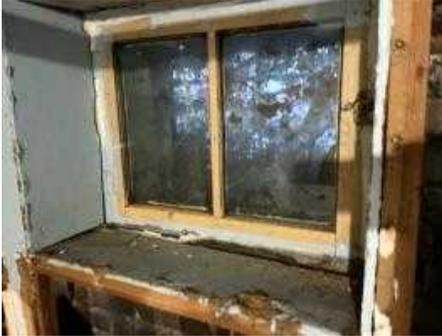
Windows: *Neglected*

WINDOW TUNE-UP is recommended. Windows that have damaged components, frames and missing hardware should be properly restored. Missing screens should be installed. Damaged screens should be replaced.

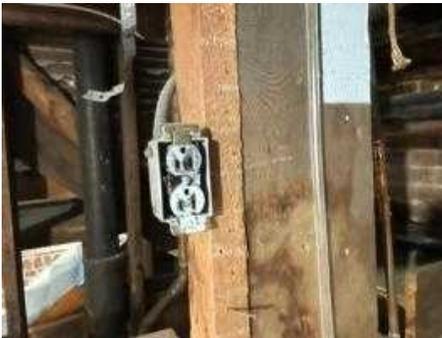
Outlets and Wiring: *IMPROVE:*

INSUFFICIENT NUMBER - of outlets for this space. Allow for improvements., EXPOSED OR SURFACE WIRE - should be protected or relocated, POOR WIRING - Non standard wiring was observed, further evaluation and repairs is recommended

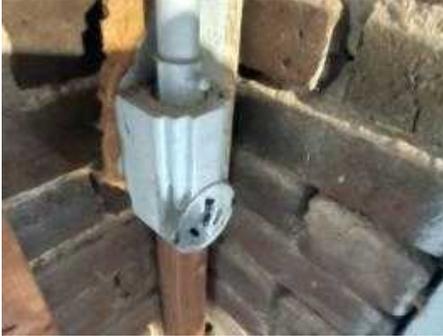
Washer and Dryer Electrical: *IMPROVE:*

NOT TESTED - The dryer 220 - outlet should be investigated and improvements made as necessary, 3-PRONG 240V RECEPTACLE for dryer is of the older type. Current standard is for a 4-prong receptacle. A new dryer, or a newer dryer you bring from a newer house would have to have the older style cord retrofitted in order to work.

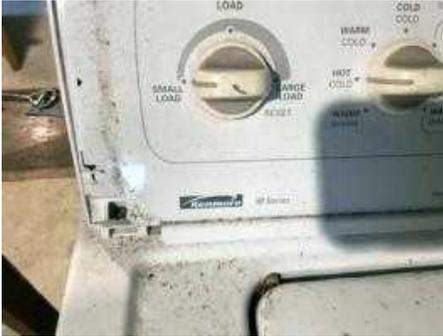
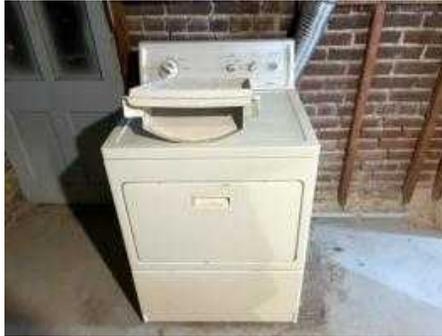
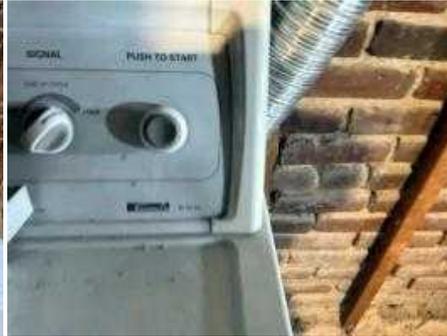
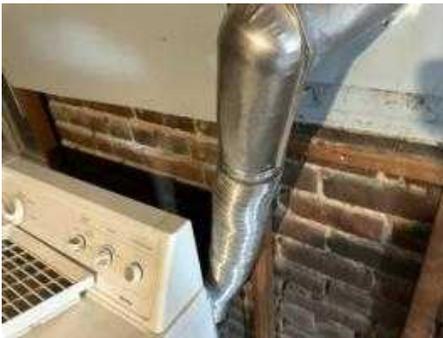
Clothes Dryer Not inspected *IMPROVE:* *Not connected.*

Dryer Vent: *IMPROVE:*

POOR INSTALLATION - Improper installation should be repaired for improved safety and function

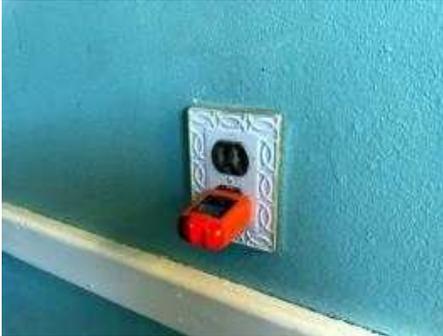
GFCI Protection: SAFETY ISSUE:
NOT PRESENT AS REQUIRED, this should be investigated and repairs made for safety and function.

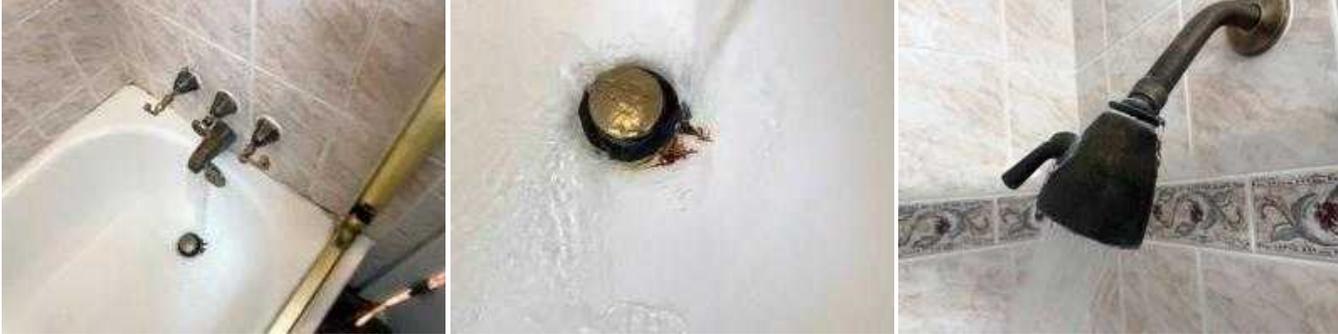
Tub/Surround: Porcelain tub and tile surround APPEARS SERVICABLE.; IMPROVE.; DEFERED COST: OLD COMPONENTS, updating would be a logical long-term improvement, GROUT loose or missing, this should be investigated and repaired as necessary. CHIPPED, damaged or rusting tub, allow for repairs

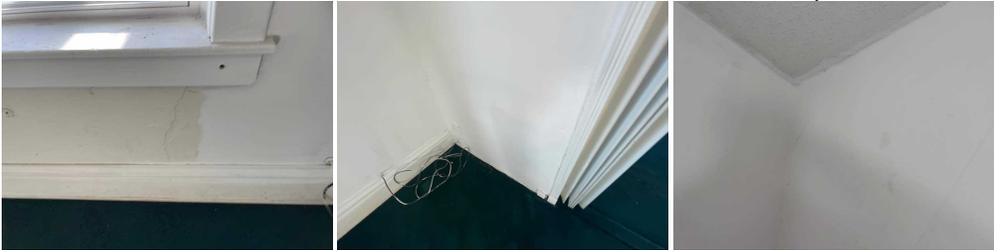
Ceiling: Drywall **APPEARS SERVICABLE:**
TYPICAL FLAWS were observed in the finishes. Allow for improvements., CRACKING was observed. In the absence of any additional movement only cosmetic repairs will be necessary. This should be investigated.

Walls: Drywall **APPEARS SERVICABLE:**
TYPICAL FLAWS were observed in the finishes. Allow for improvements.

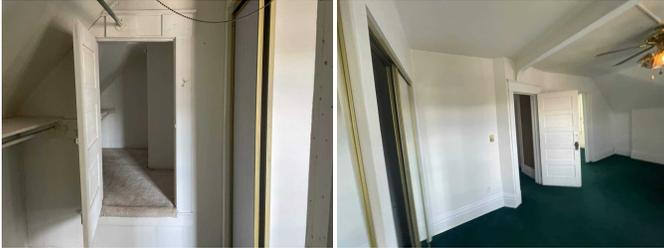
Walls: *IMPROVE:*

TYPICAL FLAWS were observed in the finishes. Allow for improvements. CRACKS was observed. In the absence of any additional movement only cosmetic repairs will be necessary. This should be investigated.

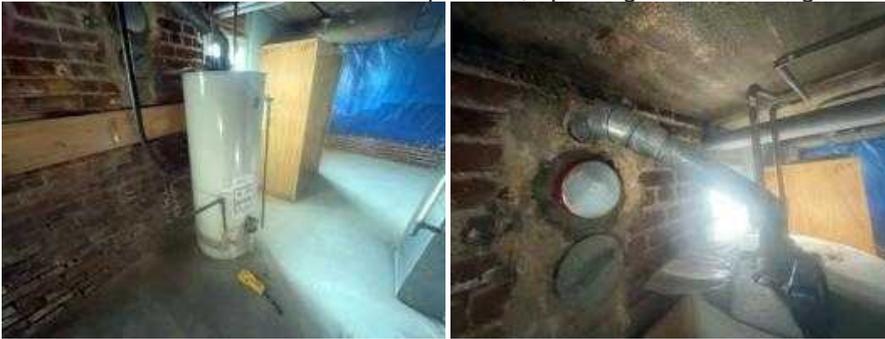
OVER ALL CONDITION: Older components, updating would be a logical improvement. **IMPROVE:**

Ceiling: Exposed framing **IMPROVE:**

TYPICAL FLAWS were observed in the finishes. Allow for improvements.

Walls: Brick and Mortar **REPAIR:**

DAMAGE was observed, allow for repairs.

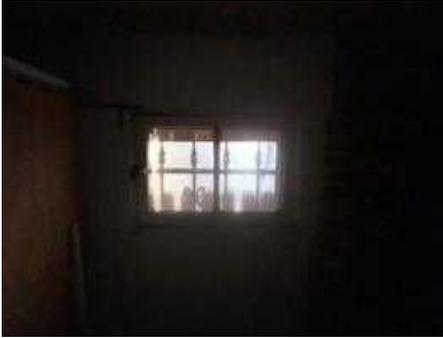
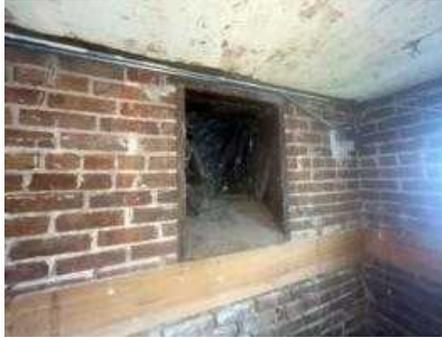
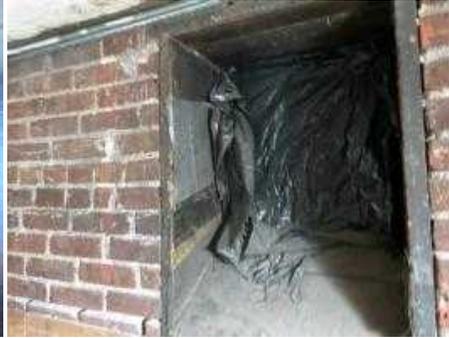
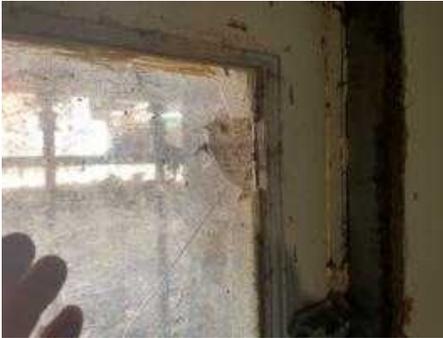
DAMAGED - allow for replacement, **WEATHER SEALS** - should be replaced.

WINDOW TUNE-UP is recommended. Windows that have damaged components, frames and missing hardware should be properly restored. Missing screens should be installed. Damaged screens should be replaced.

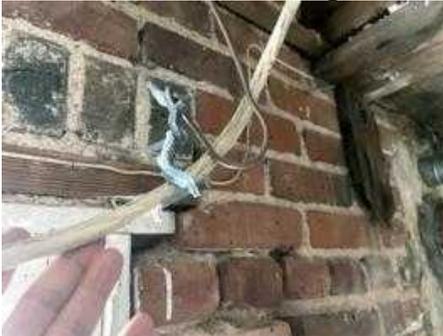
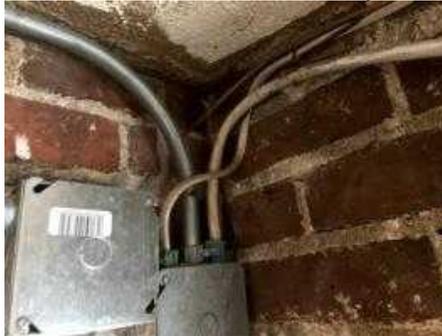
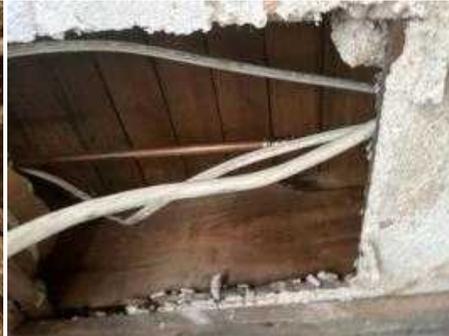
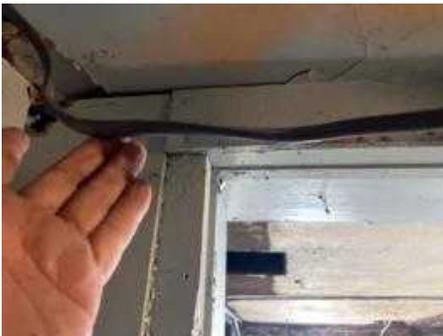
Outlets and Lights: *IMPROVE:*

Non standard wiring was observed, further evaluation and repairs is recommended

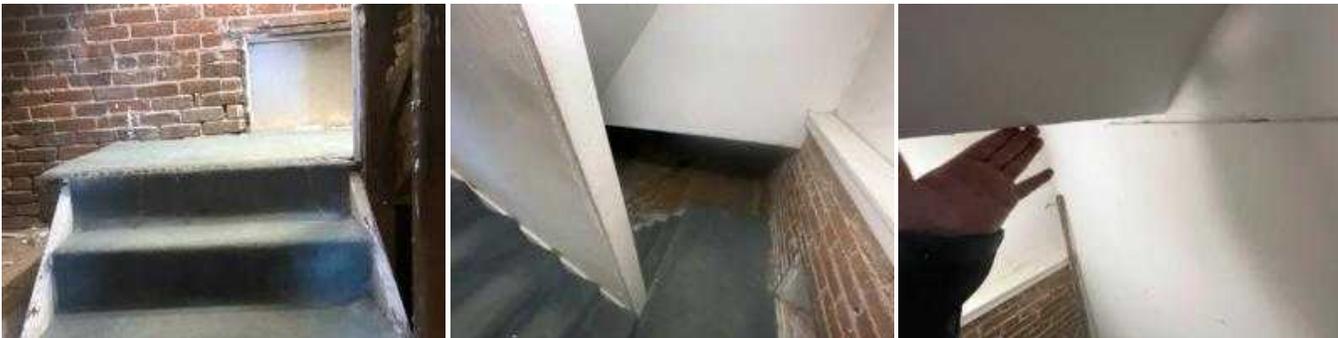
HANDRAIL MISSING OR INCOMPLETE - The handrail should be continuous for the full length of the flight of stairs., RAILING MISSING OR INCOMPLETE for improved safety, the guard railing should be installed, RISE / RUN UNEVEN - are a trip hazard., A qualified contractor is recommended to evaluate and estimate repairs., LOW HEAD HEIGHT - this is common for old homes.

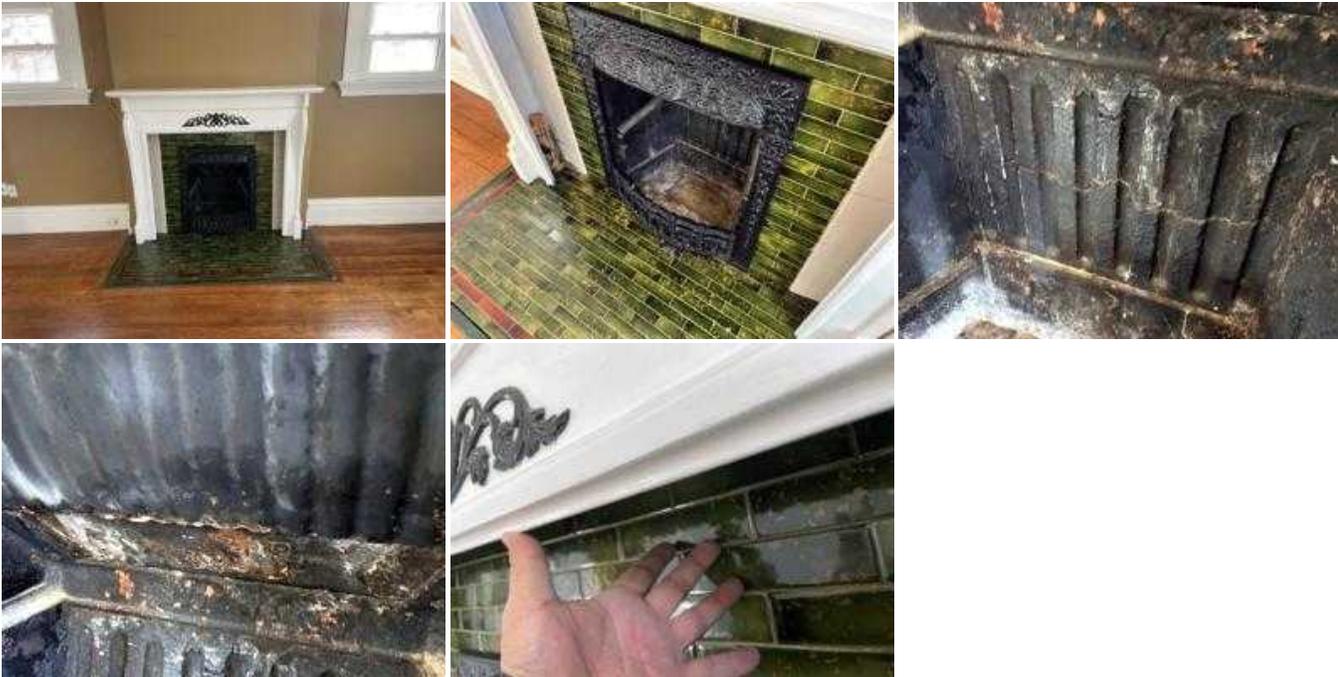
Fireplace Type: *REPAIR*; *SAFETY ISSUE*:

A qualified contractor is recommended to evaluate and estimate repairs to operate the fireplace safely. Damaged was observed. Improper clearance to combustibles. Damper inoperative. Allow for repairs and replacements.
